SAVANNAH RIVERBANK PROTECTION PROJECT

Observations on Cost, Constructibility and Performance

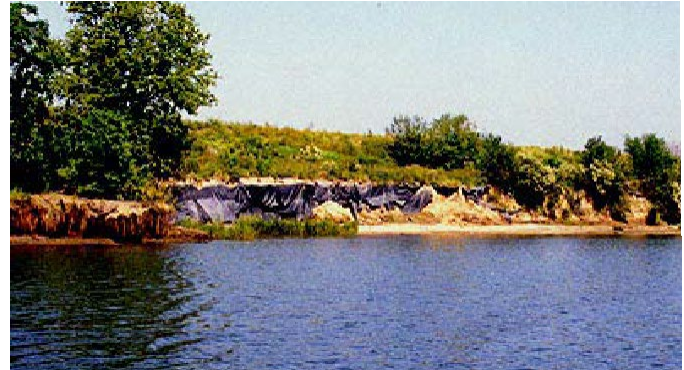
PROJECT INFORMATION: The project site is located along the north bank of the lower Savannah River, downstream from The Port of Savannah and the City of Savannah and between five and ten miles upstream from Tybee Island where the River empties into the Atlantic Ocean. The Georgia Department of Transportation and the U. S. Army Corps of Engineers have worked to maintain a 42 foot depth for shipping traffic on this portion of the river. Dikes immediately adjacent to the north riverbank provide containment for dredge material and have been threatened as evidenced by actively eroding bluffs along the riverbank. (See Figure 1)

Fig. 1: Bluff eroding into containment dike along north bank immediately upstream from test sites. Geotextile was previously placed within embankment.

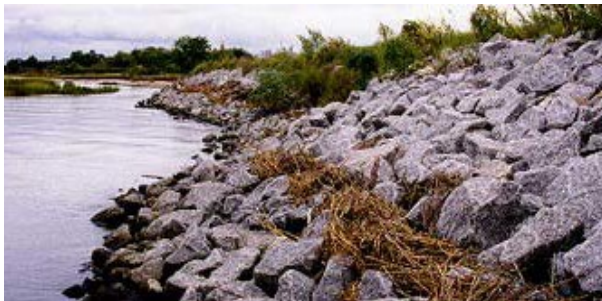
In one area of Section B the riprap appeared to suffer a loss of toe support and subsequent settling or slumping. Additional riprap material has been placed as a repair and the settling or slumping appears to continue. (See Figure 2)

Figure 2: Riprap installation at Section B. In the vicinity of the vegetation in the center of the photo, slumping continues despite repairs by adding riprap.

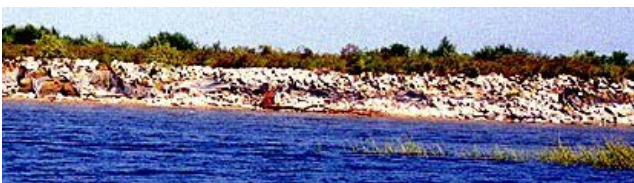
Section E sustained loss of riprap material, shredding of the underlying geotextile, and loss of embankment material near its upstream end. Due to the extent of damage it is difficult to ascertain the mode of failure with certainty. Given its nature and location, the failure appears to have the potential to propagate along the riverbank. (See Figures 3 & 4)

Figure 3: Upstream portion of riprap installation at Section E. This area experienced major washouts.

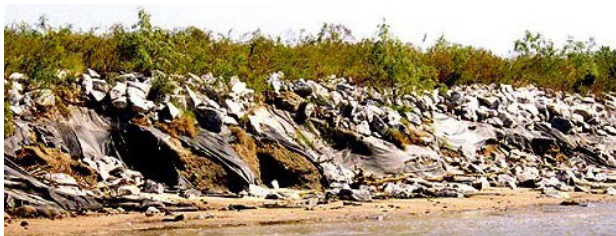
Figure 4: Close-up view of riprap failure at Section E.

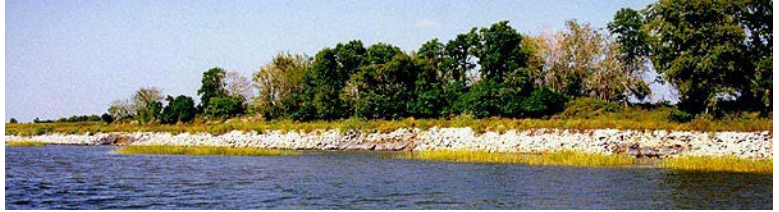
Section G sustained similar damage over three distinct stretches of riverbank which appear to be actively spreading. See Figures 5, 6, 7, 8.

Figure 5: Downstream portion of riprap Section G. This section experienced three distinct failed areas. Left is upstream, right is downstream.

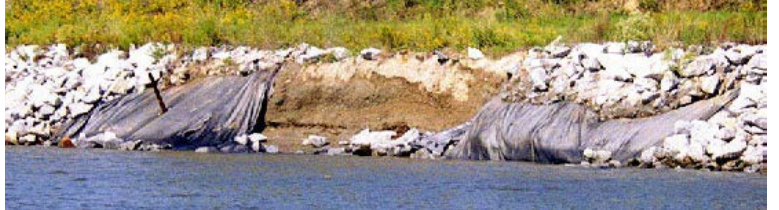
Figure 6: First (upstream) failed area at riprap Section G

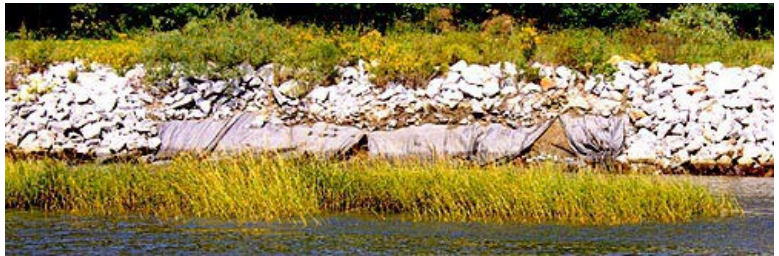
Figure 7: Second failed area at riprap Section G.

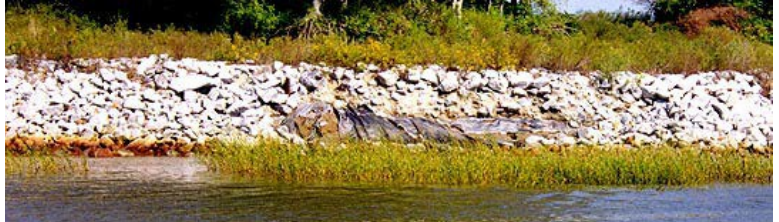
Figure 8: Third failed area at riprap Section G.

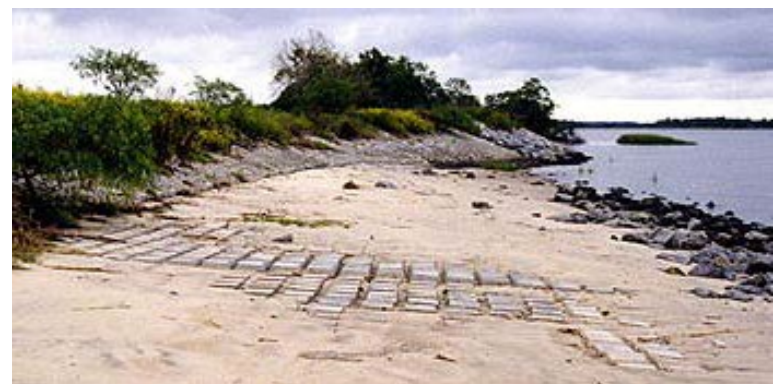
CABLED BLOCK MATS: Sections A and D were constructed using a proprietary form of cabled block mat. The river has been accreting at Section D such that much of the block mat is now covered with sand deposits. Overall this site looks good and does not appear to have been seriously challenged by the river. (See Figure 9)

Figure 9: Cabled block mat Section D looking downstream. This site has been depositional, as evidenced by the sand deposits covering the armor layer.

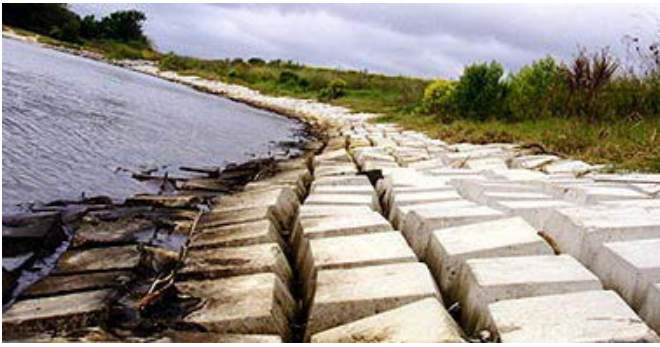
Figure 10: Cabled block mat Section A looking upstream. This site has been erosional. Differential settlement and loss of intimate contact are prevalent.

Section A has experienced multiple types of failures. Much of the installation shifts underfoot as there is widespread loss of intimate contact with the subgrade. In some areas, particularly near the water line, wide voids several inches in depth have developed beneath the blocks. The inherent tendency of the cables to restrict flexibility is evident in the many suspended, rocking blocks. The irregularities in the subgrade appear to be caused by differential settlement or erosion of the subgrade. For such challenging hydraulic conditions, this loss of contact between the blocks and the filter / subgrade is typically defined as a failure in itself, signaling the onset of more dramatic failure.

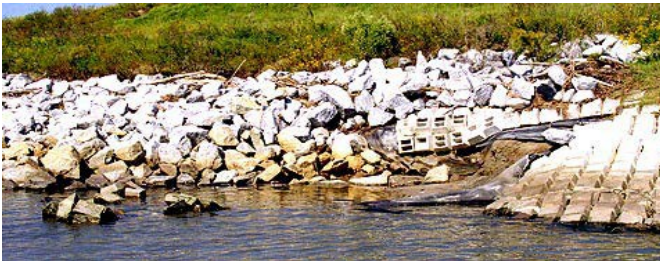
Figure 11: Cabled block mat washout at the flanking transition on the upstream end of Section A.

In other areas the mats have heaved or flipped due to inadequate hydraulic stability. The hydraulic stability appears to be least where settlements have led to protruding blocks and where there are wide gaps between the mats. This observation is consistent with the theory of increased drag and uplift forces on protruding blocks. Early attempts to stem the problems by grouting between the blocks were largely unsuccessful. On the upstream end of the section, the mats and embankment have washed away, and failure appears likely to propagate downstream. (See Figures 10 - 13)

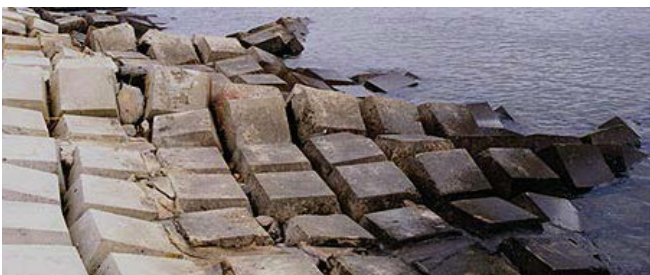
Figure 12: Heaving of cabled block mat on the upstream portion of Section A.

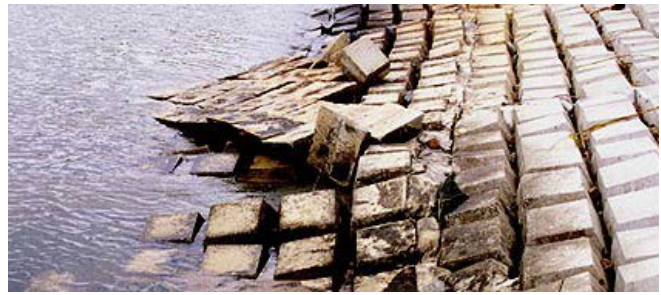
Figure 13: Flipping of cabled block mat on the upstream portion of Section A.

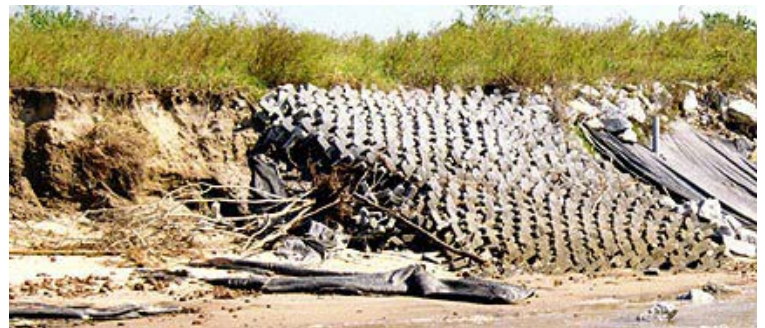
TETRAPODS: A proprietary form of tetrapod was used as flanking for both ends of Sections C and E, for a total of four locations. The tetrapods were considered to be the most costly and difficult to construct of all the options tested, but were evaluated for use in special cases such as flanking. Major failure resulted at both tetrapod installations on Section E. The upstream flanking appeared to be failing progressively from the upstream end toward the downstream end, as would be expected in the case of undermining and hydraulic instability; the upstream end is arching fairly rigidly over a void created by undermining. Fragments of broken tetrapod units were seen scattered downstream. The downstream flanking appeared to be failing progressively from the toe upward, as would be characteristic of a loss of toe support and subsequent separation and loss of interlock. The results observed on this project raised questions regarding their suitability for use in conditions such as these. (See Figures 14 - 16)

Figure 14: Washout of tetrapod units at upstream flanking of Section E. Upstream edge is undermined and generally not flexing with the subgrade.

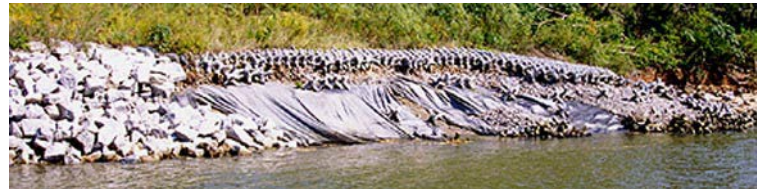
Figure 15: Washout of tetrapod units at downstream flanking of Section E. Failure appears to have developed from the toe.

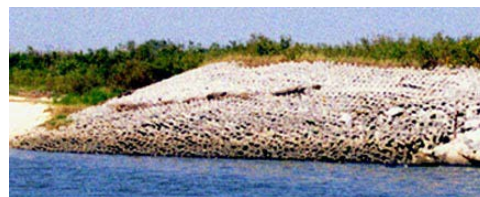
Figure 16: Tetrapod flanking of Section C performed better and remained intact.

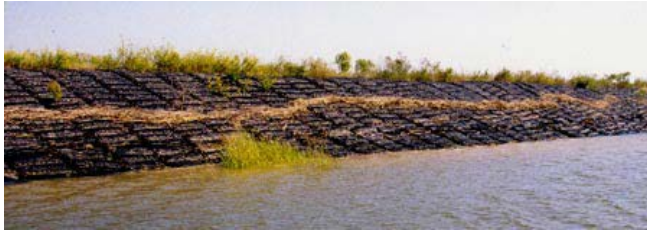
MARINE MATTRESSES: Marine mattresses were used to construct Sections C and F. The performance of the marine mattresses surpassed that of the other alternatives used. The preliminary design report by Olsen Associates, Inc. states that “The most important performance criteria for an erosion control structure is its inherent stability.” On this project, only the marine mattress consistently demonstrated stability. (See Figures 17 & 18)

Fig. 17: Marine mattress Section C looking downstream. Each unit is anchored at top of slope by burying an extending tail of geogrid. Pairs of units are spliced together end to end. Stability has been maintained throughout.

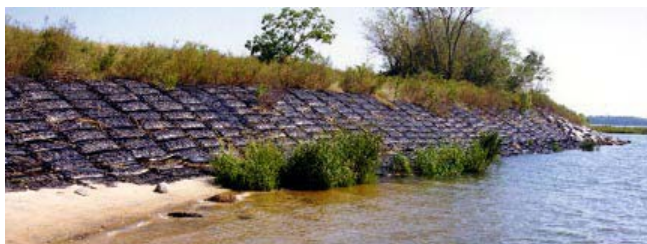
Fig. 18: Marine Mattress Section F looking downstream. Stability has been maintained throughout.

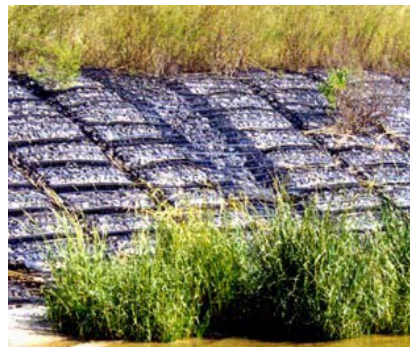
Second, the side-to-side gaps between marine mattress units are excessive in some cases; in one notable case, the patch over the gap was inadequate. These types of problems are addressed in the repair document mentioned above. (See Figure 20)

Fig. 20: An excessively wide gap at the side-to-side joint between marine mattress units has been repaired by filling the gap with stone and braiding a geogrid patch in place over the stone. Lesson learned: due to the excessive width of the gap, baffles are needed to prevent movement of stone down the slope.

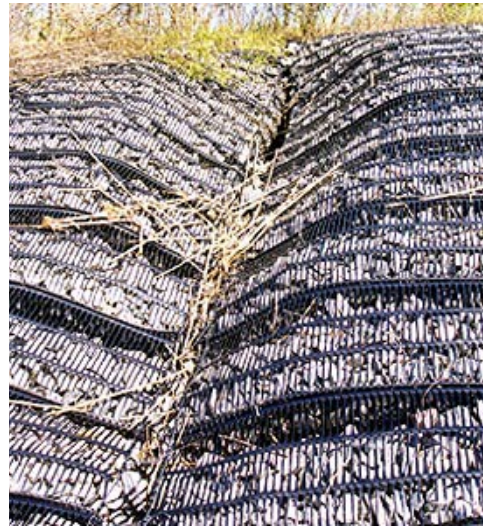
Last, investigation of a large void beneath two marine mattress units indicated faulty installation of the geotextile filter. It appears that in the immediate vicinity, the geotextile beneath the units was discontinued. Although the gap in the geotextile coverage was in the upper portion of the slope, the

subgrade apparently eroded during a high water event and the void propagated, primarily downslope beneath the geotextile. The development of the void is considered directly attributable to the missing geotextile. Grouting should be considered to fill the void and future grouting may be required, depending on the lateral extent of the missing geotextile. (See Figure 21)

Fig. 21: A void two to three feet wide and two to three feet deep had developed beneath two units and near the top of the slope. Video inspection of the void showed that the geotextile underlayer was missing and apparently had not been placed. The upper edge of the geotextile was found at the lower end of the visible gap (the top third of this photograph). The void had propagated downslope.
