# The performance of modular block walls reinforced with geogrid subject to strong ground motions during the 2016 Kaikoura earthquake

**ABSTRACT:** The existing Dashwood Bridge on State Highway 1 over the railway line was a pinch point and quite dangerous with the high number of trucks using it. The bridge was built in 1932 in a continuous 4 span concrete beam, and no longer met the NZTA seismic standards. It was decided, due to the strategic route strategy risk, that a new structure was required with improved alignment across the railway. One of the main design considerations was the seismic load case (acceleration specified was 0.6g), because the structure is located only 12km from a large earthquake of  $M_w = 6.5$  which occurred on 21st August 2013 (17km depth, and 20km east of Seddon). The 70-week project was started in January 2014 and the modular block reinforced soil retaining walls were started at the end of June 2014 taking approximately 1 month to complete the two walls, one at each end of the culvert. The 2016 Kaikoura earthquake occurred at two minutes after midnight on 14th November 2016 in the north eastern part of the South Island of New Zealand, with magnitude  $

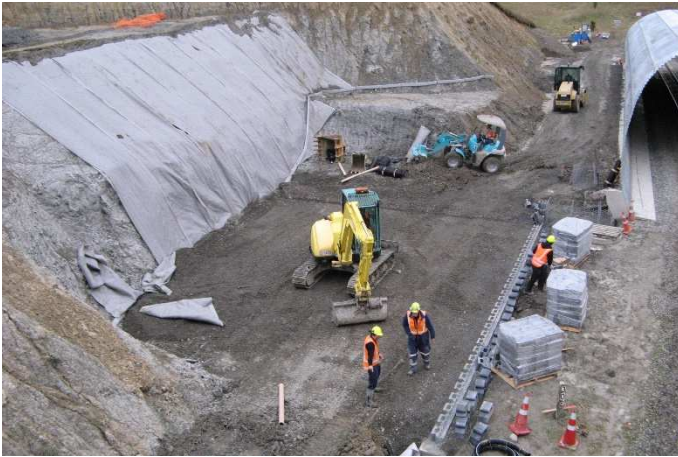
The overall project duration was 70 weeks starting in January 2014 and the modular block walls were started at the end of June 2014 and took approximately 1 month to complete, see Figures 5 and 6.

Figure 5. Modular block east wall at Dashwood at early stage

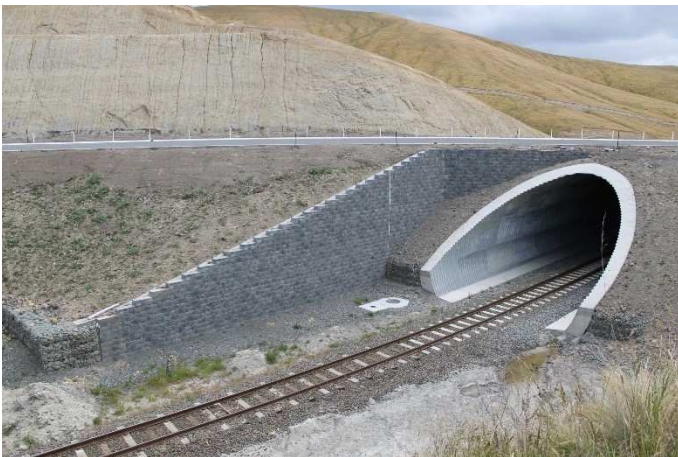
Figure 6. Modular block west wall at Dashwood completed

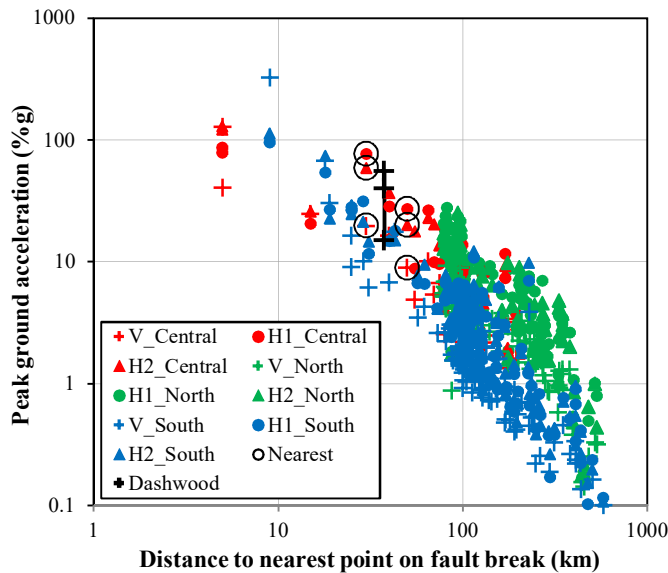
The attenuation diagram shown in Figure 8 has been made with some adjustments to the estimated epicentral distances as follows:

Figure 8. Attenuation of peak ground acceleration with distance from Kaikoura earthquake fault break  
(Source: <ftp.geonet.org.nz>)

Based on these adjustments, the distance axis on Figure 8 is referred to as the “distance to nearest point on fault break” in km. Also, on Figure 8, the large black open circular symbols highlight the recordings from the two stations (SEDS and MGCS) which were mentioned previously as being closest to the Dashwood retaining walls.

Taking account of the discussion above and the data summarised in Figure 8, the estimated peak ground accelerations at the site of the Dashwood walls have been assessed by interpolating the recordings from the nearest two sites as shown in Table 1.

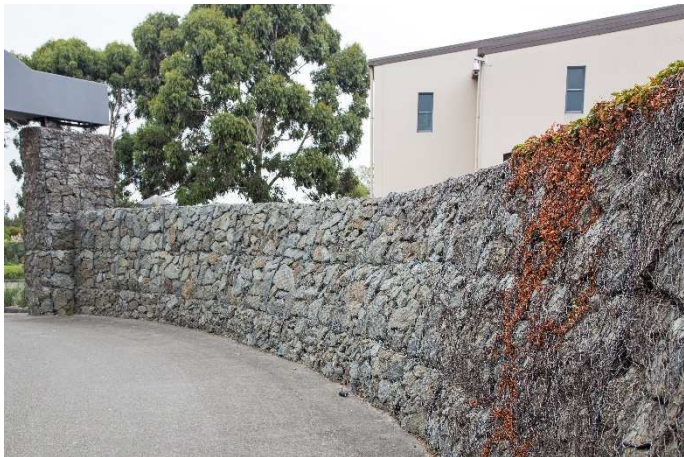
Figure 10. Gabion wall at winery south of Blenheim

A free-standing architectural gabion wall at a winery located 7km south of Blenheim Marlborough Girls College underwent permanent deformation from the earthquake, as shown in Figure 10.

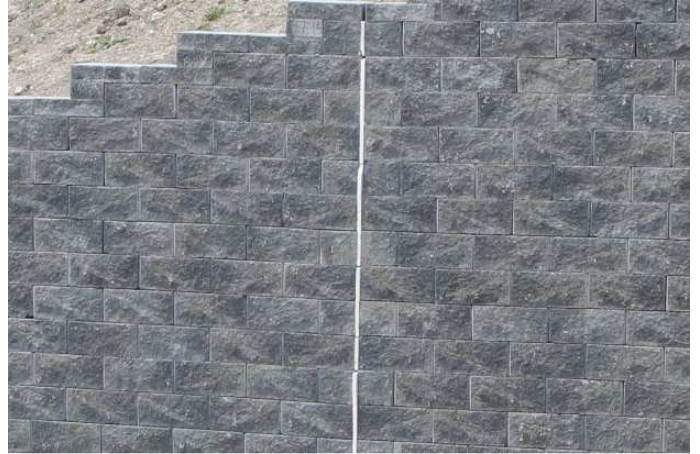
A slip joint was designed into the wall to accommodate differential settlement at the transition where the wall extends up the sides of the culvert at an angle. There has been some minor relative movement of the upslope section (<10mm) however it is unknown if this had occurred as a result of the earthquake shaking or under normal loading conditions. Figures 13 and 14 show the slip joint both pre- and post-earthquake.

Figure 13. Slip joint pre-earthquake

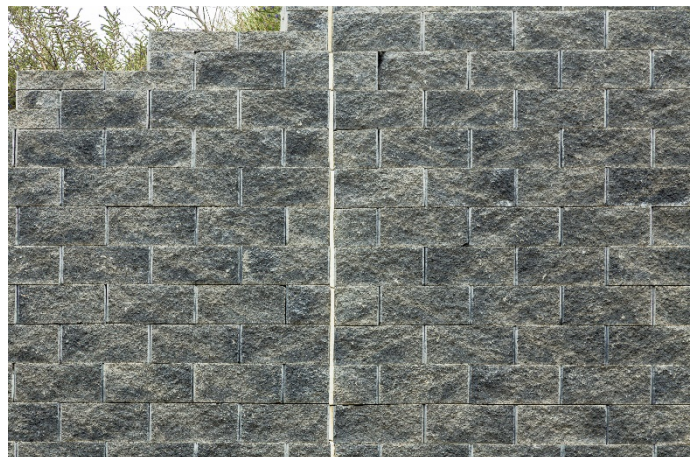
Figure 14. Slip joint post-earthquake

It is clear from these photos that the walls have performed extremely well during the strong shaking which took place during the Kaikoura earthquake with no signs of distress.
