GEOGRID INSTALLATION REPORT

HIGLEY AND ELLIOT

South-Bound Lanes of Higley Road, North of Elliot Road
Gilbert, Arizona

CMT Project No. 1403
September 3, 2019

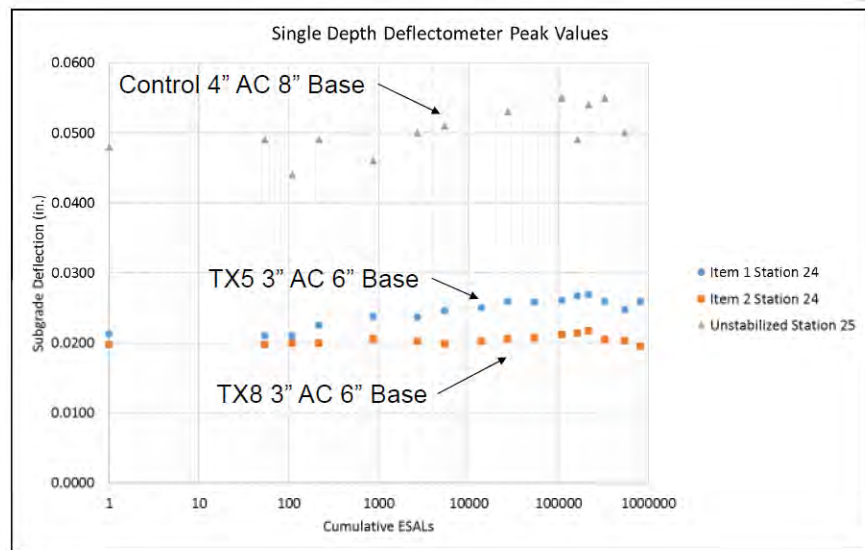
- Measured deflections in the stabilized sections were approximately one-half of those observed in the un-stabilized section.

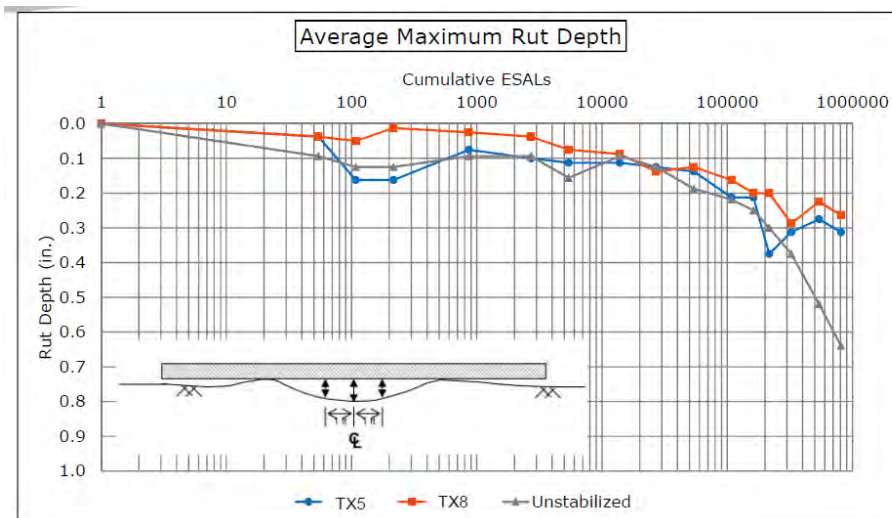
- Both geogrid stabilized pavement sections improved the rutting resistance when compared to the un-stabilized test section.

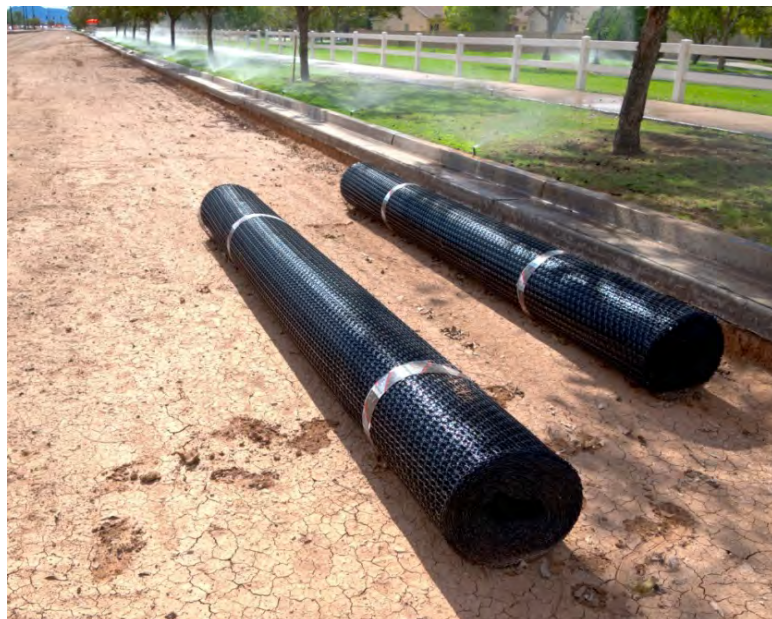
Photo No. 1 - Rolls of Geogrid

The subgrade eventually dried out to the point where compaction could be obtained and the contractor began placing the grid and the aggregate base. The contractor stockpiled some aggregate base at the north end of the site. The TX-8 Geogrid was delivered on site in rolls as shown in Photo No. 1.

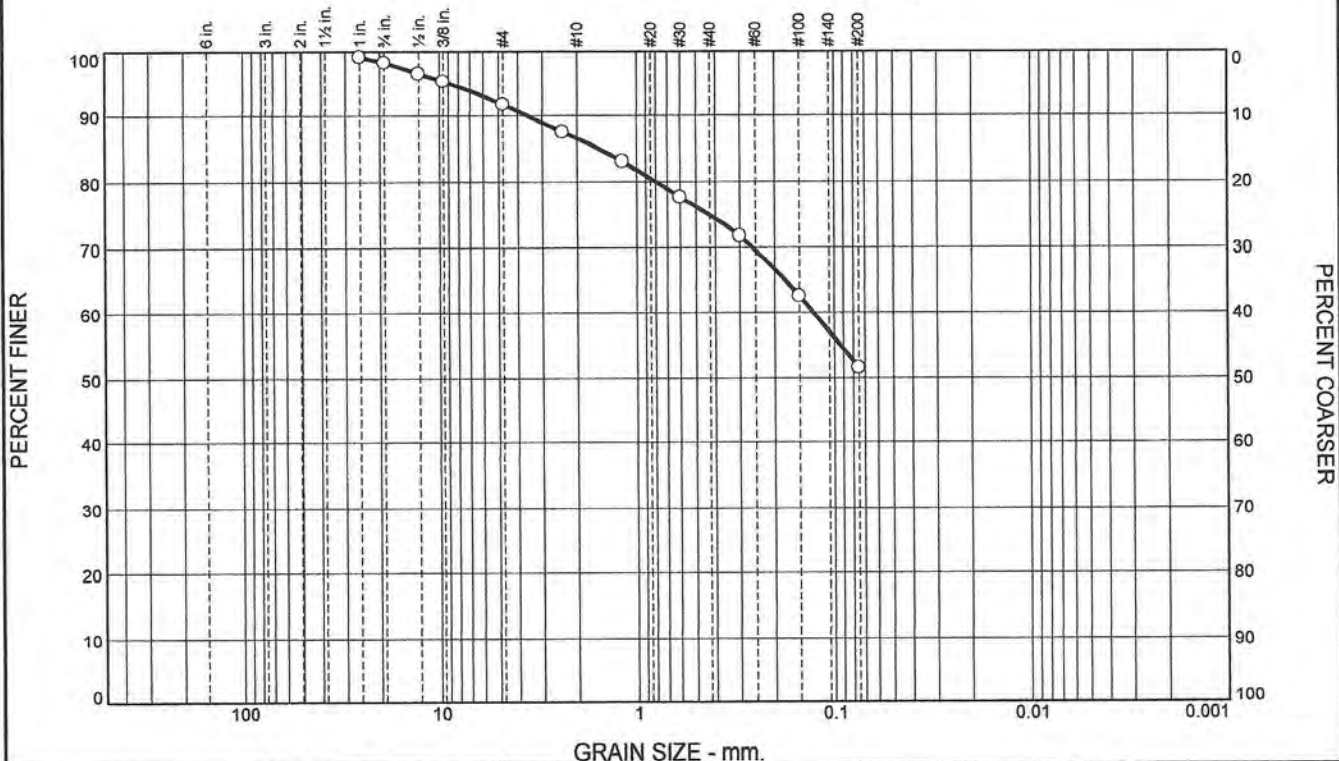
Particle Size Distribution Report

% +3"	% Gravel		% Sand			% Fines	
	Coarse	Fine	Coarse	Medium	Fine	Silt	Clay
		6.5	5.3	11.6	23.3	51.5

SIEVE SIZE	PERCENT FINER	SPEC.* PERCENT	PASS? (X=NO)
1"	99.1		
3/4"	98.2		
1/2"	96.5		
3/8"	95.3		
#4	91.7		
#8	87.4		
#16	83.0		
#30	77.6		
#50	71.6		
#100	62.5		
#200	51.5

PL= 18 **Atterberg Limits** LL= 40 PI= 22
 USCS= CL **Classification** AASHTO= A-6(8)

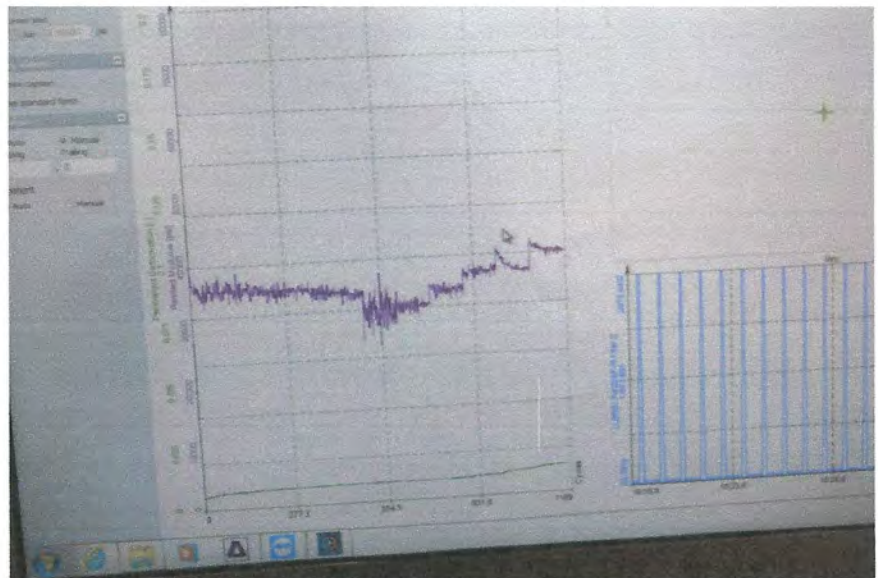
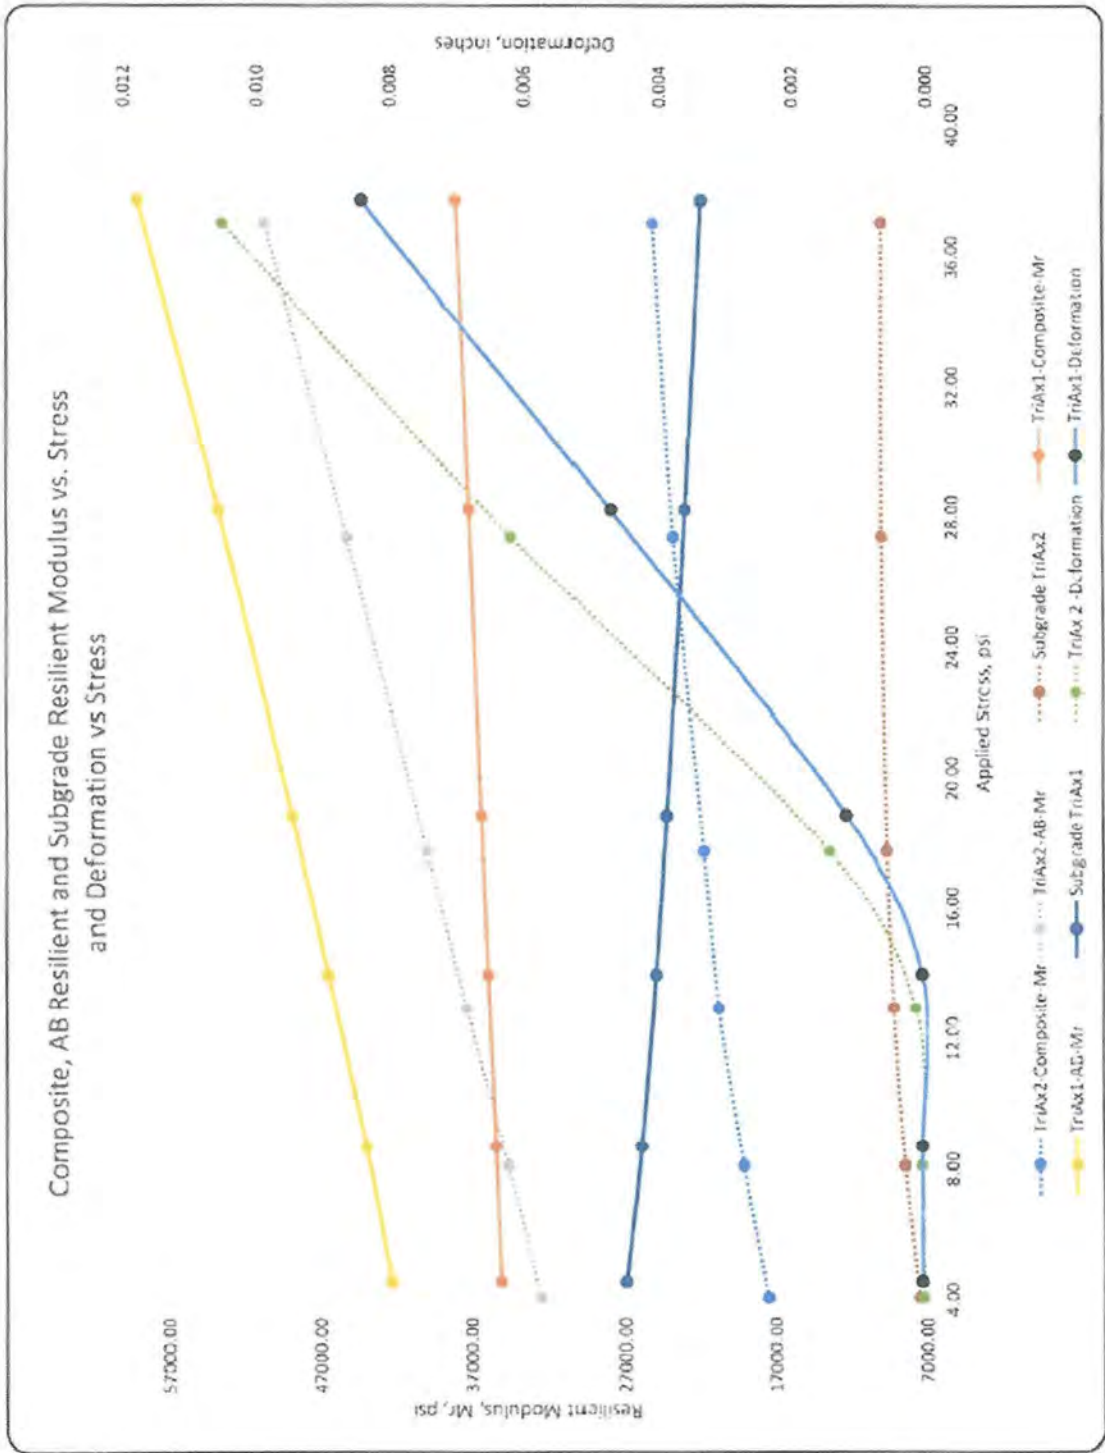
APLT GRAPICAL PRESENTATION DEFORMATION VS STRESS

**AB AND SUBGRADE, RESILIENT MODULUS VS. STRESS
AND
DEFORMATION VS. STRESS**

CMT witnessed the initial setup and APLT testing. The results indicated that the AB layer coefficient increased from the value of 0.12 to 0.29, higher than other stabilization methods that range from 0.17 to 0.23. The results also indicated that measured subgrade modulus increased significantly because the addition of the TriAx Geogrid reduced the stress felt by the subgrade.
