PAVISION®

Date:	March 27, 2017
Location:	California, La Media Road
PaVision® Serial Number:	#001

Background

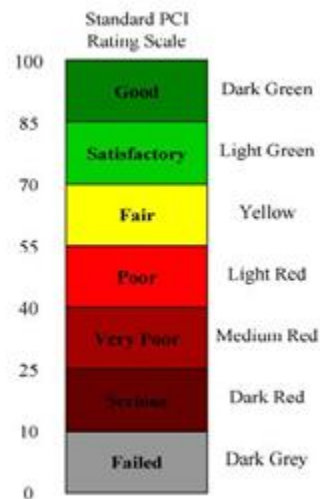
Error! Reference source not found. contains the final PCI scores for each segment as defined by the user. For reference, figure 2 depicts the PCI scale as described in ASTM D-6433.

Figure 2. ASTM D-6433 scale for PCI ratings.
