Performance of Geogrid-Stabilized Flexible Pavements

Gregory J. Norwood and Jeb S. Tingle

July 2014

Final report

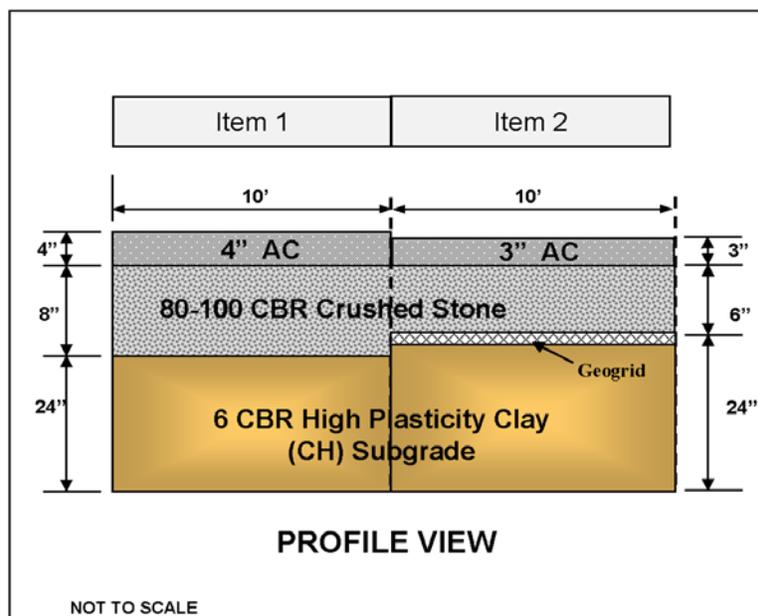
Figure 1. Test-section profile view.

The structural design of the test section was developed by Tensar Corporation. Tensar designed two unique pavement structures to quantify the benefit associated with the use of a geogrid in a flexible pavement structure over a firm subgrade. A profile view of the test section is shown in Figure 1. Each test item consisted of a 10-ft-wide by 50-ft-long testing area. The subgrade for both test items was constructed with 24 in. of high-plasticity clay (CH) placed to achieve the target California Bearing Ratio (CBR) value of 6%. A CBR of 6% was selected to provide a test section with medium subgrade strength. Item 1 was constructed with an 8-in.-thick unstabilized aggregate base course consisting of a crushed limestone flexible base meeting TXDOT Grade 2 Type A specifications. Item 1 was surfaced with a 4-in. hot-mix asphalt (HMA) concrete layer. Item 2 was constructed with a 6-in.-thick flexible base course of the same material, stabilized by placing a triaxial geogrid at the base-subgrade interface. Item 2 was surfaced with a 3-in. HMA layer. The two test items were constructed simultaneously to minimize variability and ensure consistency between the two pavement structures. All construction and traffic testing occurred under ERDC's Hangar 4 pavement testing facility, which minimized the potential for moisture variations due to environmental factors.

The structural design of the test section was developed by Tensar Corporation following the guidelines set forth in the AASHTO 1993 design guide (AASHTO 1993) and their SpectraPave4Pro™ software. The unstabilized control item was developed using the tools and tables provided in the second edition of Pavement Analysis and Design (Huang 2004). The designed structural number for the unstabilized item is 2.88. The geogrid-stabilized item was assigned a structural number of 2.92. SpectraPave4Pro assigns the geogrid-stabilized layer a layer coefficient of 0.267 for use in calculating the total structural number of the geogrid-stabilized item. For further information on the design structural number of the geogrid-stabilized layer, please reference Tensar's SpectraPave4-Pro™ software.

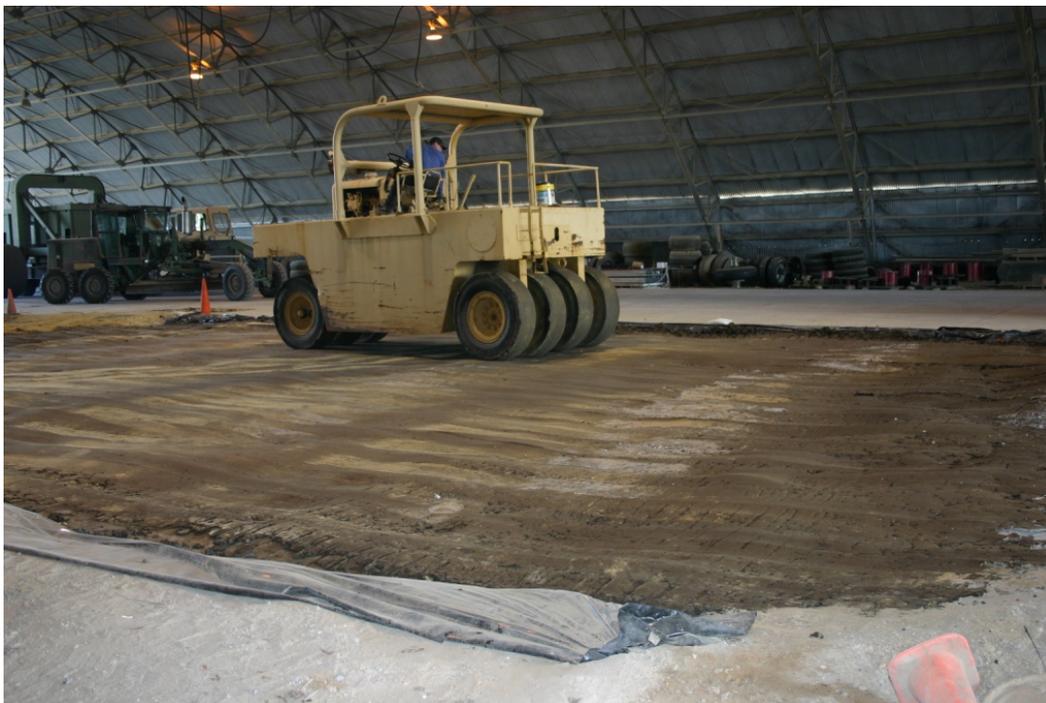
Figure 4. Crushed limestone base-course material being placed.

The crushed limestone material was placed in 8- to 10-in. lifts and compacted using a large vibratory steel-wheel roller. Figure 4 shows the crushed limestone material being dumped in place, while Figure 5 shows the material being compacted.

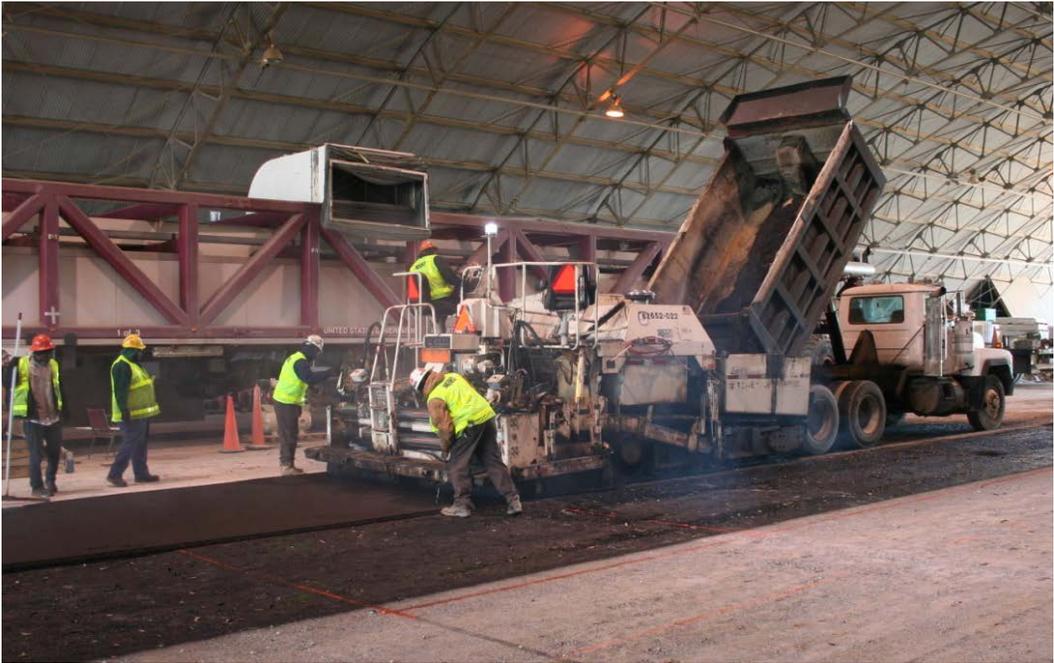
Figure 6. Test section during application of first HMA layer.

The HMA used as a surface course for this testing was representative of local highway mix for Mississippi. This mix is a 9.5 mm nominal maximum aggregate size (NMAS) surface mix. Gradation and pertinent laboratory characteristics of the HMA are shown in Table 1. Table 2 represents the Asphalt Institute recommended values for Superpave mix design for anticipated traffic levels of 300,000 to 3,000,000 ESALs. Placement of the HMA is shown in Figure 6.

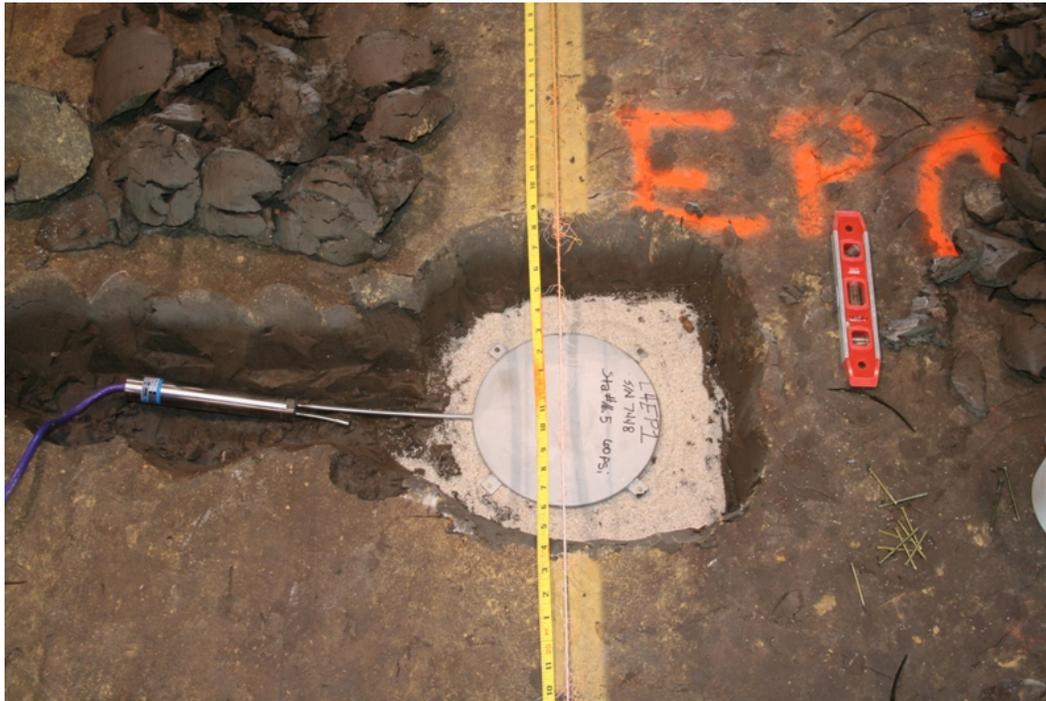
Figure 8. Installation of an earth pressure cell.

of 100 psi were installed in the subgrade, and 200-psi EPCs were installed in the base course. Figure 8 shows an EPC being installed 2 in. below the surface of the subgrade at the interface with the base course.

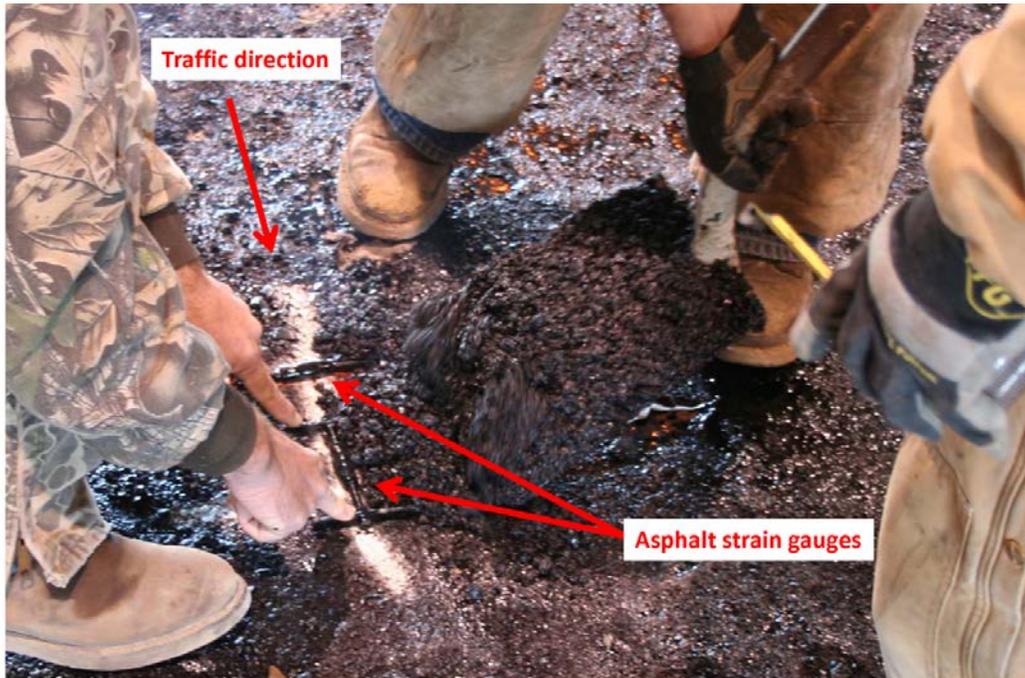
Figure 9. Installation of asphalt strain gauge.

Tensile strain at the bottom of an HMA layer provides a quantitative measure of the pavement response during trafficking. Increases in permanent, or plastic, strain lead to pavement failure. For this study, strain at the bottom of the HMA surface was measured using dynamic asphalt strain gauges (ASGs) in both the transverse and longitudinal directions. The strain at this location can be used to estimate the fatigue life of the HMA surface layer of the pavement. The ASGs were manufactured by Applied Geomechanics and are capable of measuring a range of $\pm 3,000$ microstrain. The gauges were placed on the surface of the base course, and HMA from the asphalt paver was placed as cover over each of the gauges immediately prior to paving of the entire test section. This process is shown in Figure 9.

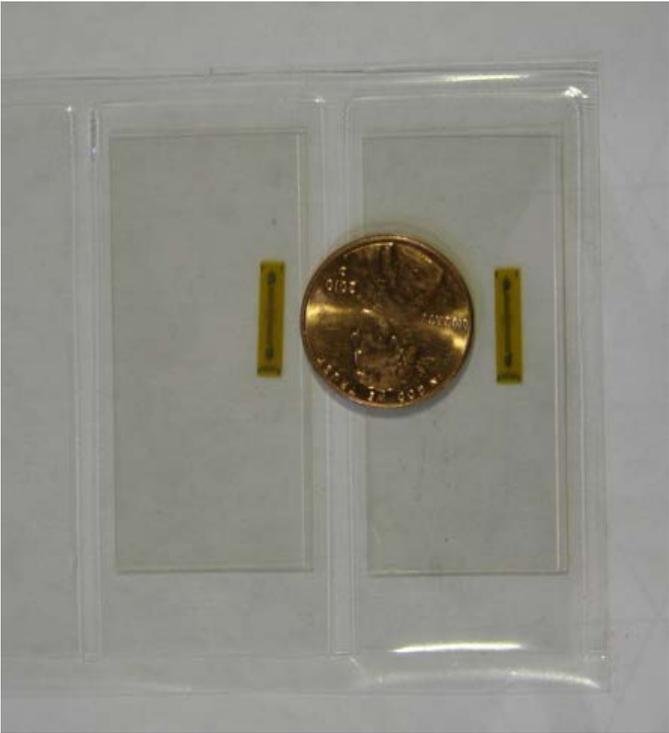
Figure 10. Geogrid strain gauges.

Strain gauges were attached to the individual ribs (in between the nodes of a single rib) of the geogrid. Vishay Micro-Measurements EP-08-230DS-120 gauges, shown in Figure 10, were installed on the geogrid. The strain gauges were covered with Aqua-Seal to prevent moisture damage. Finally, an epoxy coat was applied to provide additional protection from aggregate damage to the strain gauges. Figure 11 shows the installed gauges.

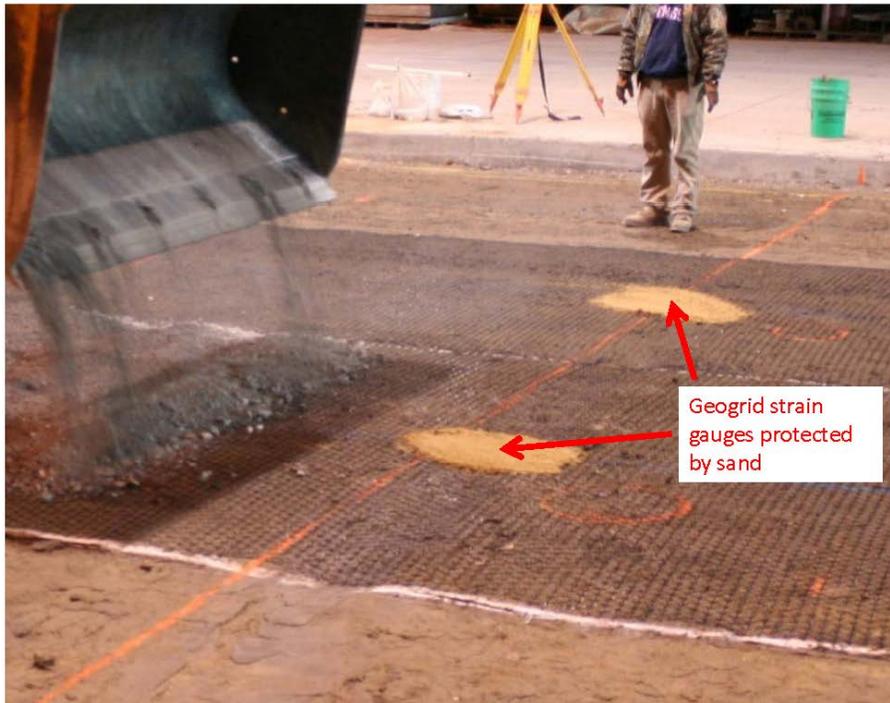
Figure 13. Installation of geogrid strain gauges in the test section.

Gauges were applied to the individual ribs (in between the nodes of a single rib) of the geogrids. The strain gauges were located at the positions indicated in Figure 12. Wiring was laid in a trench in the subgrade below the geogrid to prevent damage during base-course installation. The wooden supports were removed, and the strain gauges were covered with a thin layer of sand to minimize damage due to large aggregates during base-course construction as shown in Figure 13.

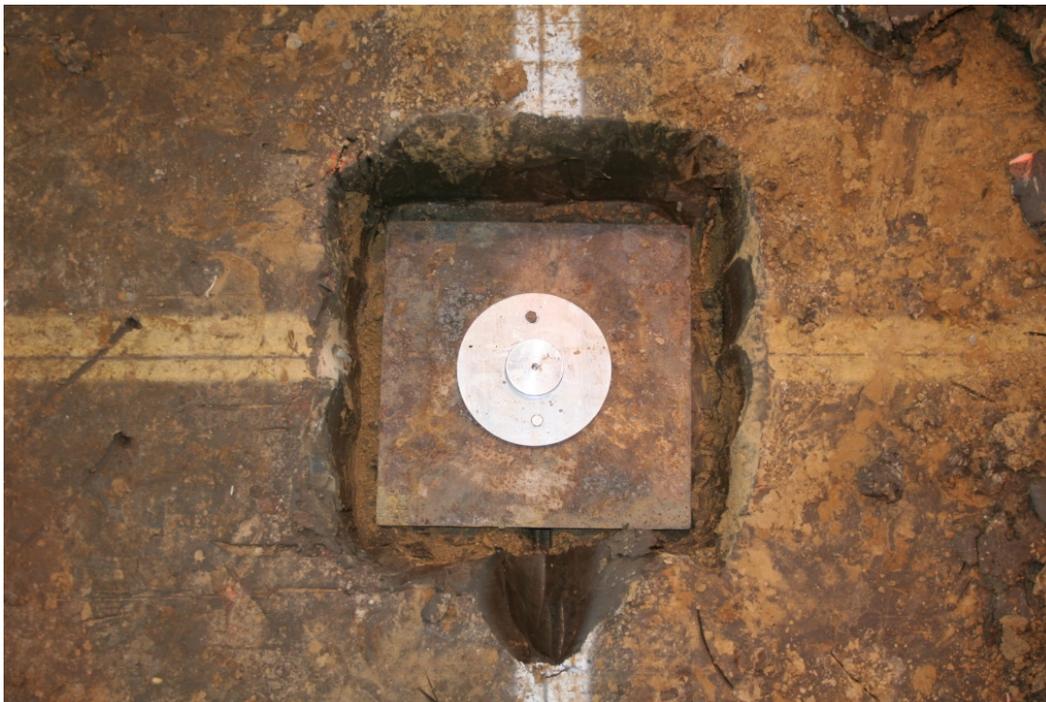
Figure 14. Installed SDD.

Vertical deflections in the subgrade were measured using single-depth deflectometers (SDDs). One SDD was placed in the middle of each test item along the centerline of traffic. The SDD was placed such that the shaft was anchored at a depth of 9 ft. from the top of the subgrade. A linear velocity displacement transducer (LVDT) with a range of ± 2 in. was placed in the housing such that it was in contact with both the anchor rod and the surface plate as shown in Figure 14. Thus, the LVDT measured movement of the plate 2 in. below the base-subgrade interface relative to the control point located at a depth of 9 ft.

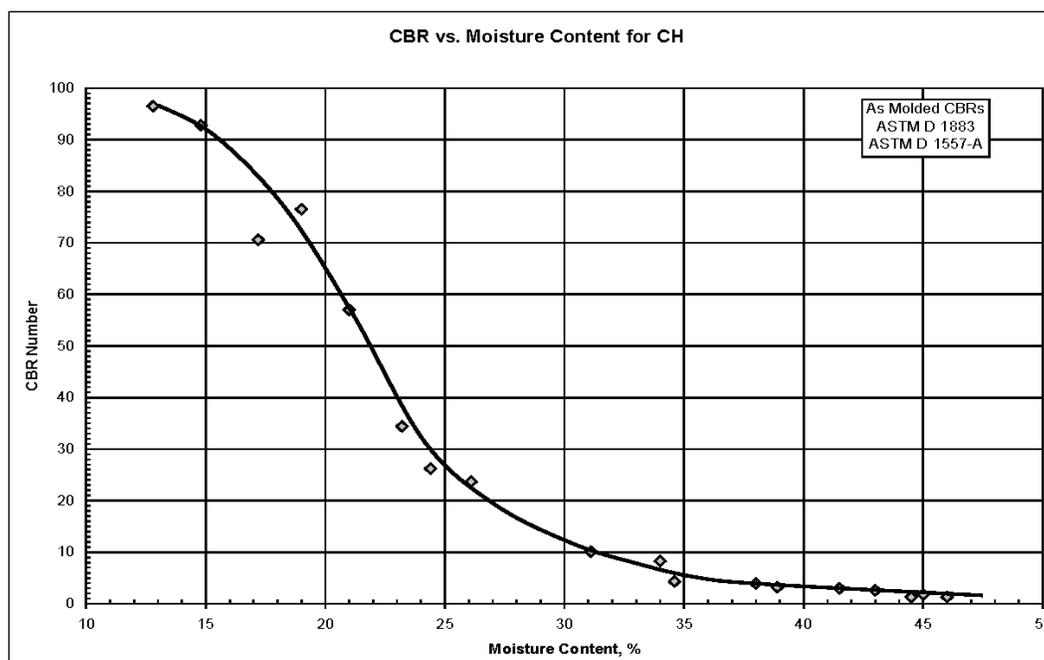
Figure 15. Historical moisture content/strength relationship for Vicksburg Buckshot Clay.

The measured oven-dried moisture content for both items is consistent with the historical values for 6 CBR Vicksburg Buckshot Clay. Figure 15 displays historical CBR vs. moisture content relationship for the Vicksburg Buckshot Clay. Values from the field in-place CBR tests show subgrade strengths ranging from 5.9 to 6.3%.

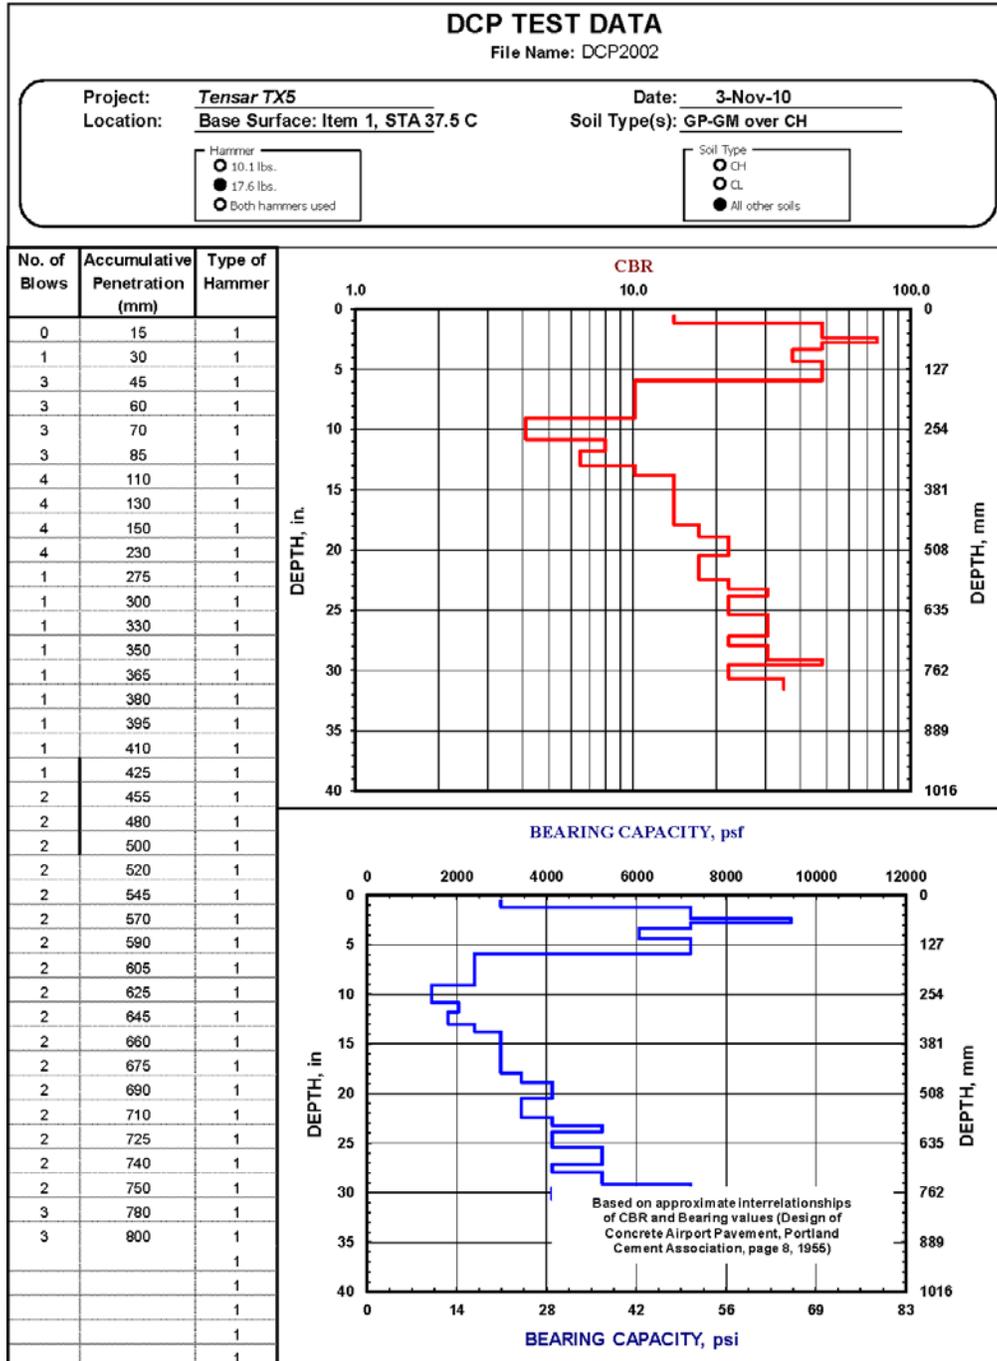
Figure 16. As-built DCP results for Item 1 station 37.5.

A series of Dynamic Cone Penetrometer (DCP) tests were performed to further characterize the strength of the unbound pavement layers. DCP tests were performed after construction of the base and subgrade layers, following the procedures described by ASTM D 6951-09. Measured values of the DCP index (millimeters of penetration per hammer blow) were converted to CBR strength using the relationship developed by Webster et al. (1992, 1994). As-built DCP results are shown for Item 1 Station 37.5 in Figure 16 and Item 2 Station 25 in Figure 17. The DCP tests were conducted immediately after the base course was placed and compacted, not allowing time for the base course to “set-up” or harden to the full 100 CBR. The field CBR values were conducted several days later, which allowed the base course time to harden and is reflected in the results previously presented in Table 3.

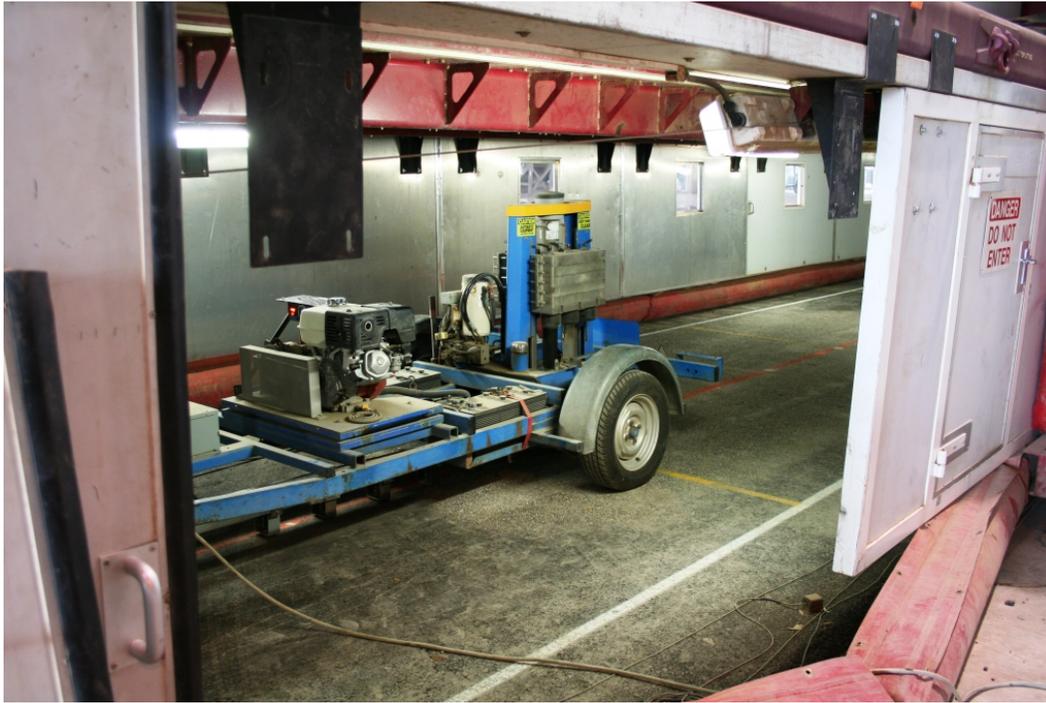
Figure 18. FWD testing inside HVS.

Falling Weight Deflectometer (FWD) tests were performed on the surface of both test items after construction as shown in Figure 18. Results from the FWD tests were evaluated in terms of the Impulse Stiffness Modulus (ISM). The ISM is the ratio of the applied load to the measured plate deflection. Higher ISM values represent a stiff pavement while low ISM

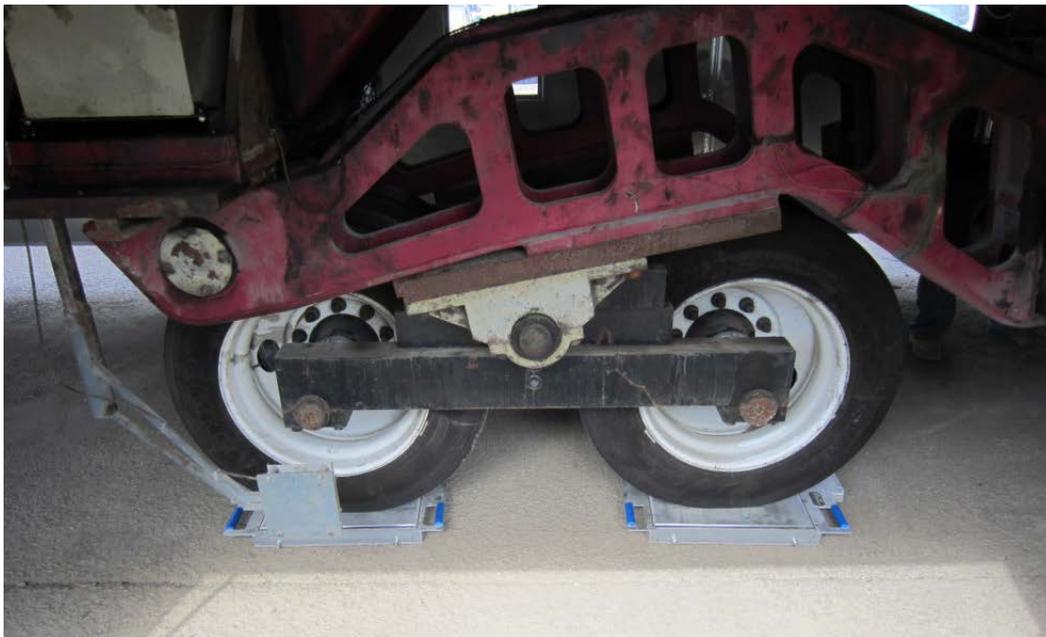
Figure 20. Verifying the applied load on the HVS dual-wheel tandem axle configuration.

Accelerated traffic testing of Items 1 and 2 was carried out using the ERDC HVS. A dual-wheel tandem axle configuration was used to apply the traffic to the test items. Figure 20 shows the wheel configuration used during testing. The dual-wheel tandem axle was subjected to a nominal load of 20,000 lb. Wheel loads were verified prior to testing by concurrently weighing each axle with portable aircraft wheel scales. Tire pressures were maintained at 120 psi throughout testing of both test items. The equivalent axle load factor for this configuration is 2.08. Therefore, one pass of the HVS is equal to 2.08 equivalent standard axle loads (ESALs). To minimize the effect of temperature on rutting results, testing on each item was conducted at a constant pavement temperature of 77°F.

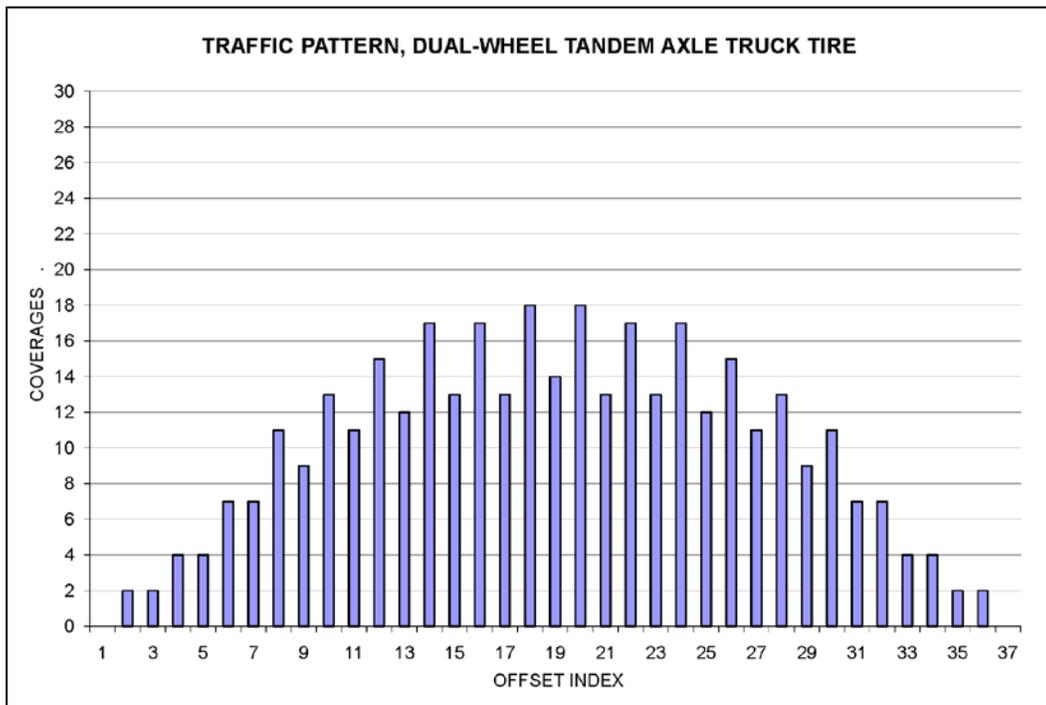
Figure 21. Traffic pattern applied during trafficking.

Each test item was subjected to a uniformly distributed bi-directional traffic pattern displayed in Figure 21. The lateral offset indices refer to 1-in. increments along which the wheel travels longitudinally. Thus, the extent of the lateral wander associated of this traffic pattern is approximately 3 ft. A 3-ft-wide wander pattern was utilized to mimic previous studies (Timm and Priest, 2005) as well as duplicate what has been observed in other test sections (Tingle and Jersey, 2007). Traffic loading was applied over the full 50-ft length of each test section. Periodic interruptions were made during

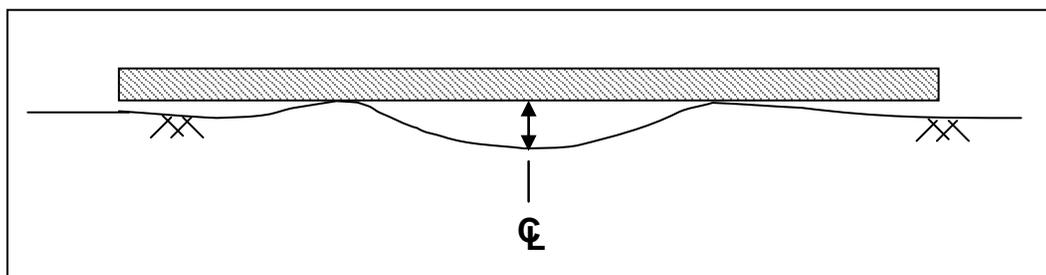
Figure 22. Measurement of rut depth.

Surface deformation and rut depth measurements were recorded at predetermined traffic intervals throughout the testing period. Surface deformation measurements represent the change in the centerline profile of the traffic lane. Surface deformation measurements were taken using a rod and level. Rut depth measurements were taken by placing a metal straight edge across the traffic lane at selected stations and measuring the maximum rut depth. The maximum rut depth includes the permanent surface deformation as well as any upheaval along the edge of the traffic pattern. Figure 22 displays a schematic of the maximum rut measurement concept.

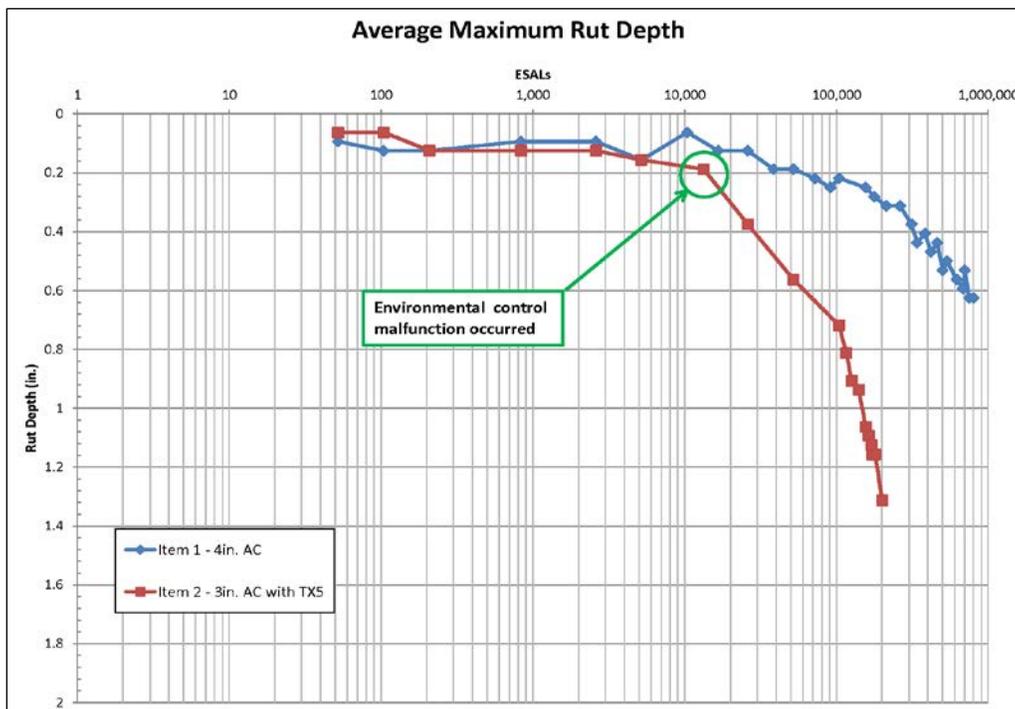
Figure 23. Average maximum rut depth.

The reported maximum rut depths presented in Figure 23 represent maximum rut depth of 50% of the traffic lane. Maximum rut measurements were taken at stations 12.5, 25, and 37.5 of the traffic lanes. The average of the maximum rut depth measurements was reported. Surface deformation measurements are presented in Figure 25. The reported surface deformation for each pass was calculated by averaging rod and level measurements taken at 1-ft increments along the full length of the traffic lanes. Measurements located at the ends were excluded due to exaggerated rutting caused by the change of direction of the HVS carriage.

Both lanes performed equally until approximately 13,000 ESALs. It should be noted that after the data collection point of 13,000 ESALs on Item 2, the HVS-A environmental control system malfunctioned. After the malfunction, the top of the pavement temperature increased to above 100°F, the middle of the pavement reached 91°F and the bottom of the pavement reached 86°F before the problem was discovered and trafficking was stopped. Figure 24 is a plot of the pavement temperature for Item 2 during the incident. The environmental system was repaired and trafficking resumed. As seen in the rut and deformation plots, Item 2 began to deteriorate after this data collection point. While Item 2 was tested to 200,000 ESALs, the data beyond 15,000 ESALs should not be used for comparative purposes because of the damage incurred during the elevated temperatures while Item 1 was maintained at a constant temperature of 77°F during testing. Permanent deformation measurements serve as a better performance measure in this case because it eliminates the majority of the effect from the induced rutting on Item 2 as a result of the elevated temperatures. Figure 25 displays how the geogrid-stabilized Item 2 performed equally to the thicker unstabilized item even after the environmental control malfunction occurred. A summary of the comparable rut depth measurements is displayed in Table 4. Only values before the environment control system malfunctioned are displayed in Table 4. Permanent deformations measurements are displayed in Table 5 and are shown for all traffic levels to display the equal performance of the two test items.

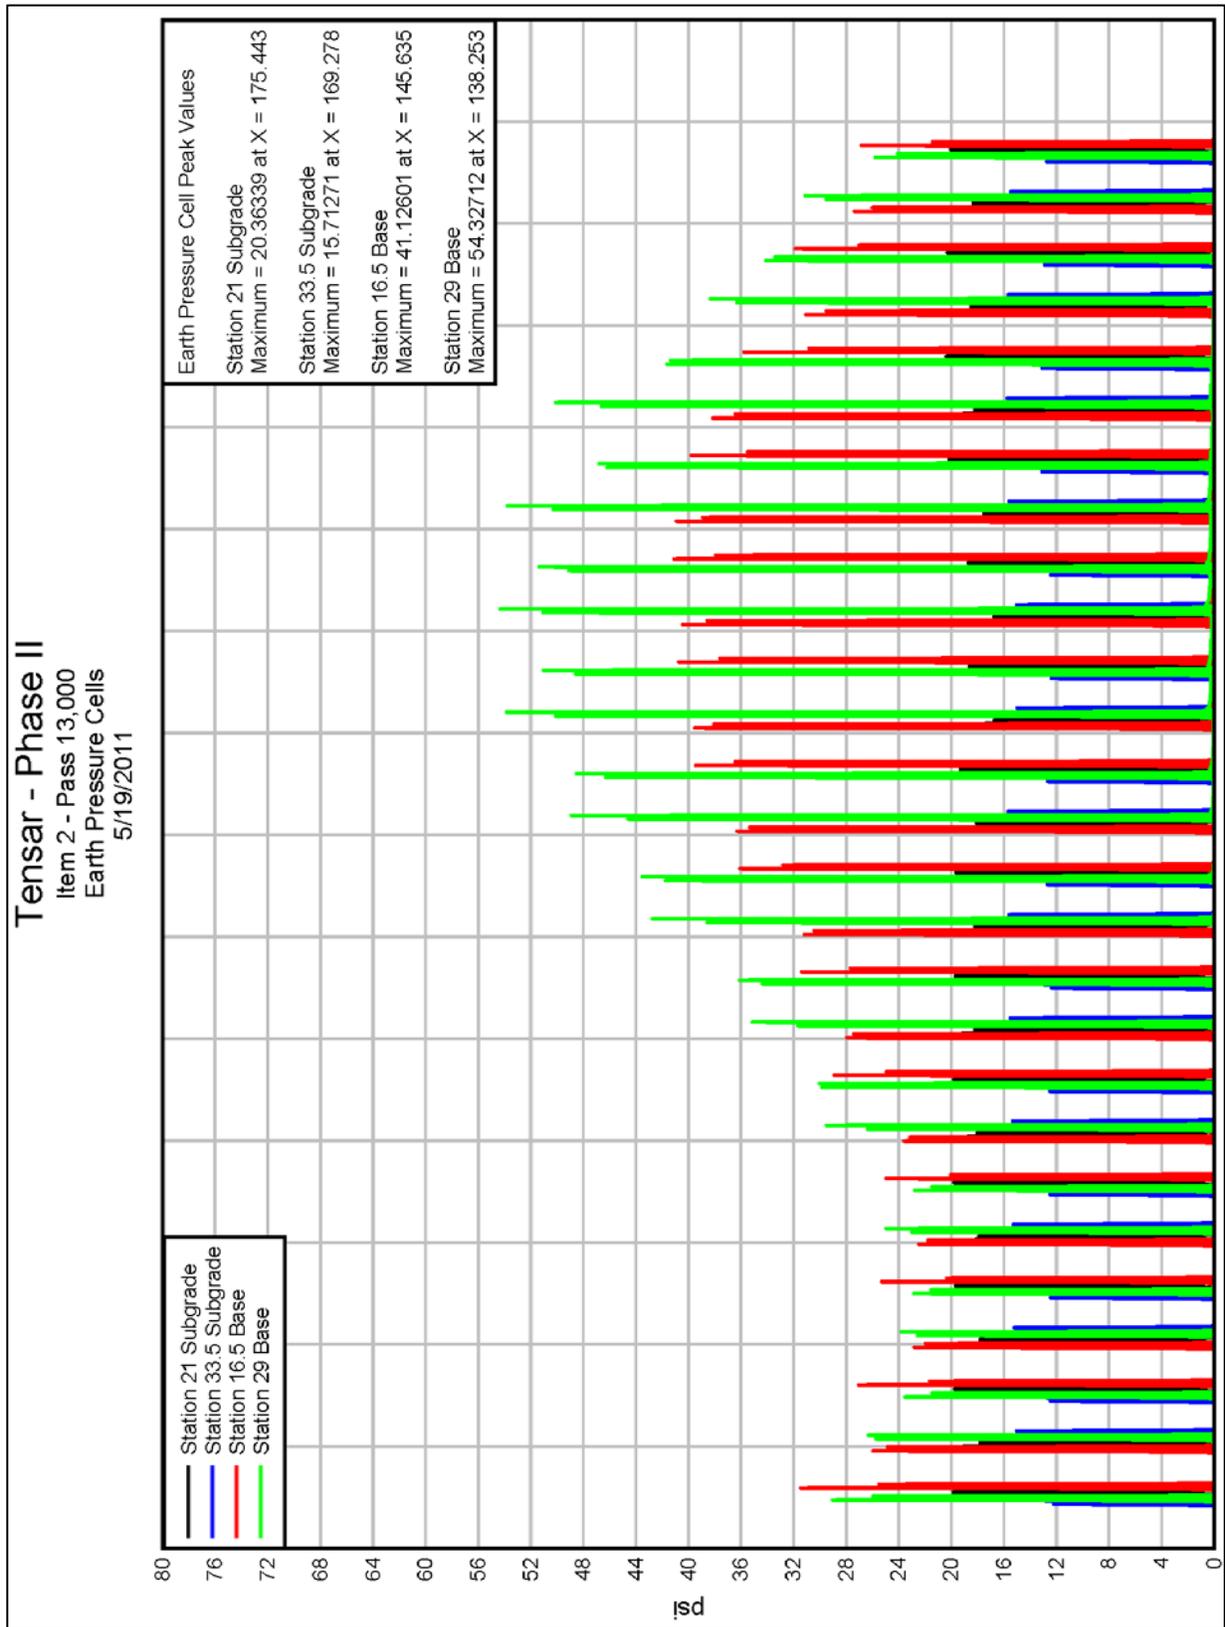
Figure 27. EPC response during 10 min of trafficking after 13,000 passes.

In order to average out the wander of the HVS and any misalignments due to construction, pressure readings were recorded for approximately 10 min of traffic after each designated data collection point. The peak values from the 10 min of EPC readings were chosen to represent the maximum pressure reading at that specific traffic interval. Taking the maximum value from more than 10 min of trafficking helped ensure that the maximum value was recorded when the HVS wheel load was directly over the installed pressure cell. This helped to alleviate any impact on the recorded values that might have resulted from installation and alignment differences in the pressure cells between test items. Figure 27 is an example of the EPC response during a 10-min traffic test. The peak values for each EPC during the 10 min of trafficking are shown in the top right corner of the figure.

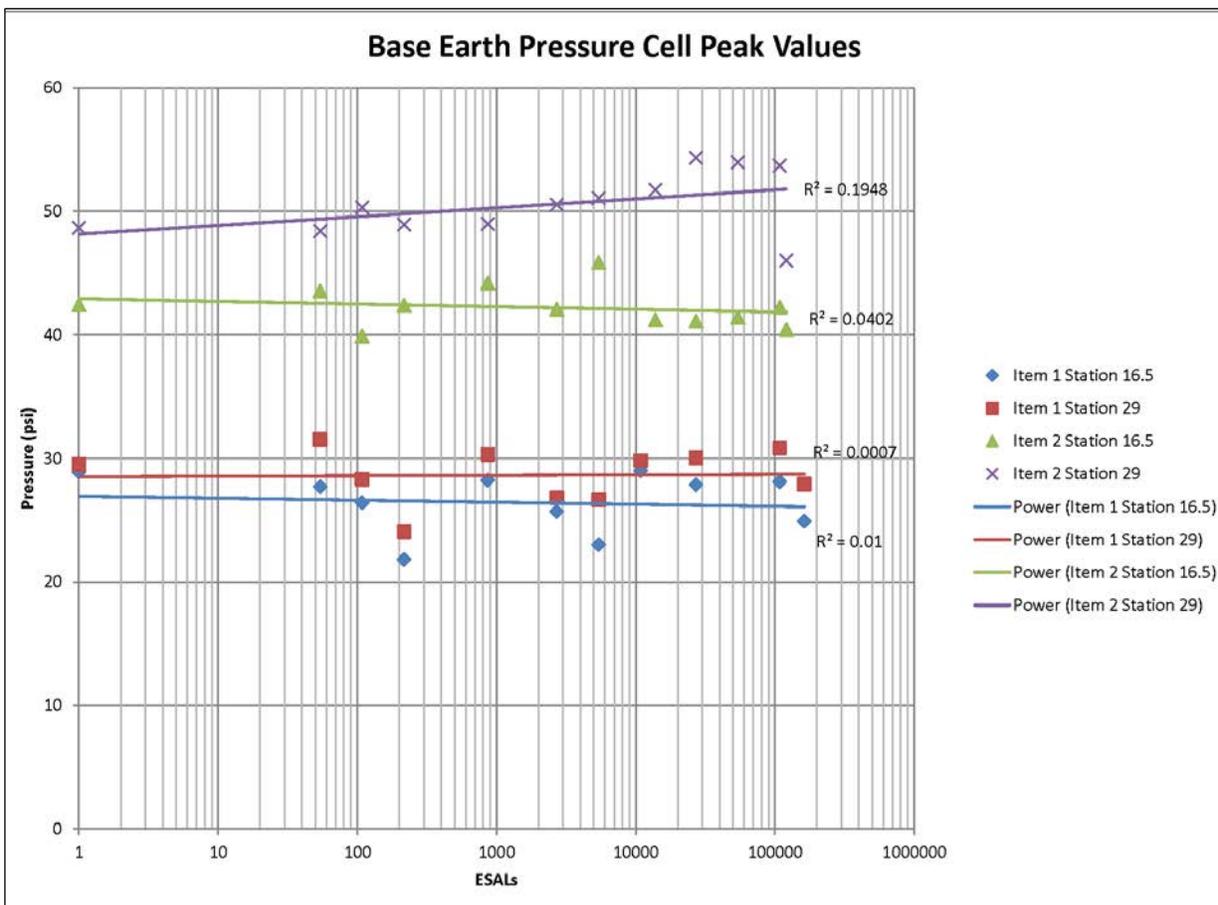
Figure 28. Change in EPC reading for base course during trafficking.

The peak EPC values from the 10-min tests were collected after each data collection point for gauges installed in both the base course and the subgrade. The changes in the EPC peak values for gauges installed in the base course of both Item 1 and Item 2 during trafficking are shown in Figure 28. Changes in the EPC peak values for gauges installed in the subgrade of both Item 1 and Item 2 are shown in Figure 29.

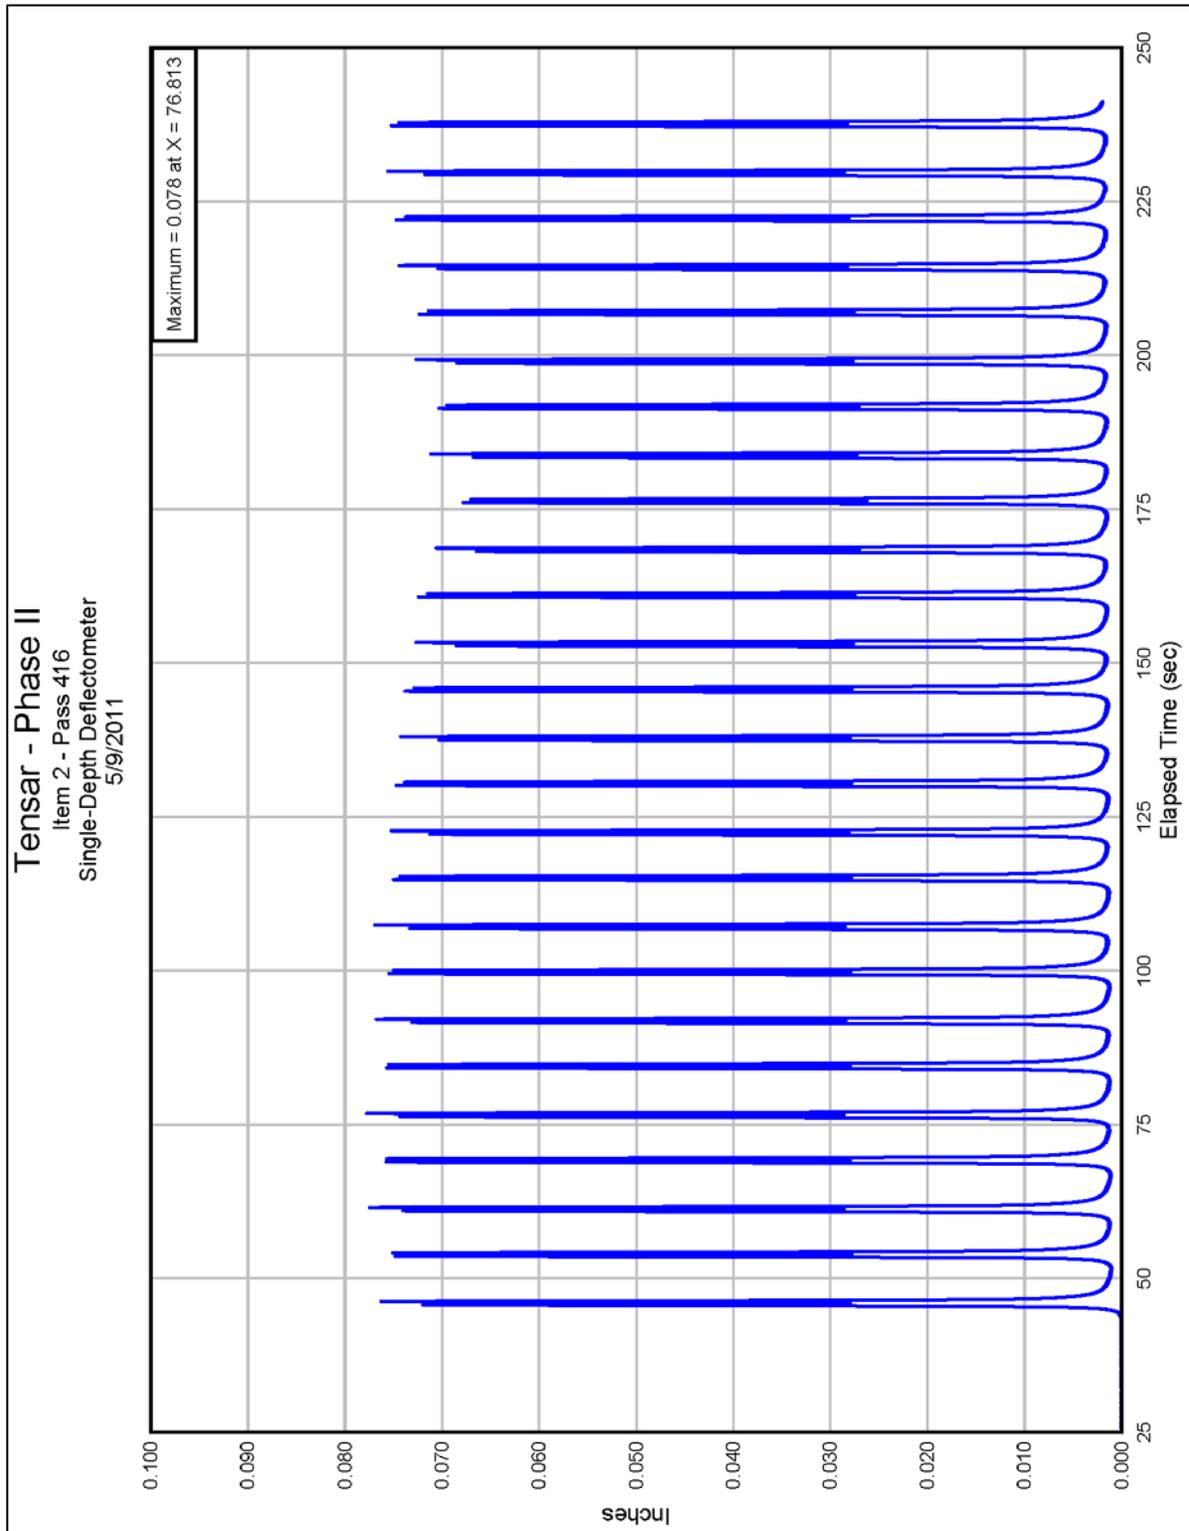
As with the EPC measurements, the deflections reported are the peak values from the 10 min of data collected after a predetermined traffic level was reached. Figure 30 is a representative plot of the 10-min SDD data

that was collected and used to derive the peak value changes over time. SDD peak value changes during trafficking are shown in Figure 31.

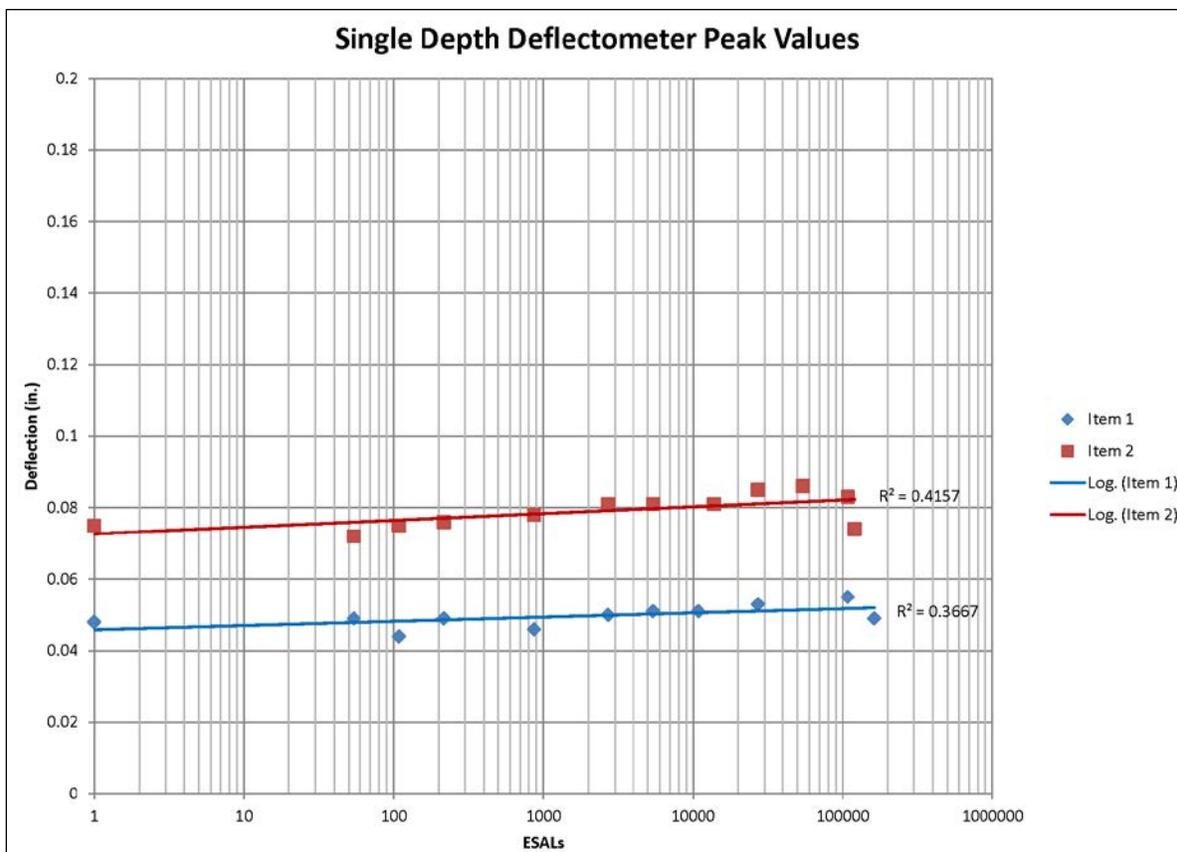
Figure 31. SDD peak value changes during trafficking.

Deflections for the geogrid-stabilized Item 2 were higher than the deflections for the unstabilized Item 1. This response was anticipated especially at the initial onset of trafficking due to the thickness of the HMA and base-course layers on Item 2 being less than Item 1.

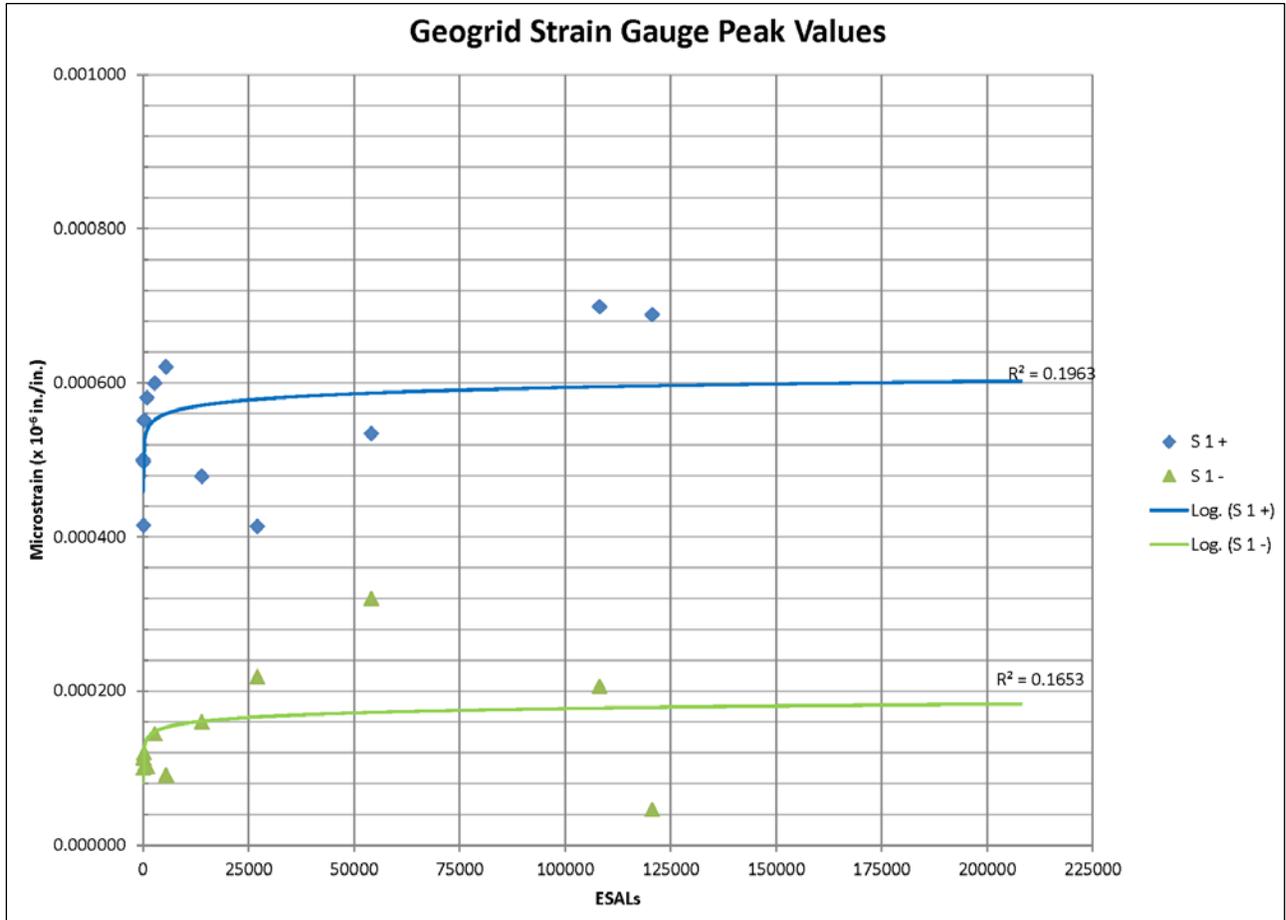
Figure 33. Geogrid strain gauge peak changes during trafficking.

At the onset of testing, instrumentation response was recorded after predetermined traffic intervals. As testing progressed, response was also recorded after any significant change in pavement rutting in addition to the recording at specified traffic intervals. Also, as with the previously discussed instrumentation, instrumentation response was recorded for 10-min intervals after each data collection point. Figure 32 displays a typical plot of the geogrid strain gauge response for the 10-min collection period. Positive strain readings are indicative of tension and negative readings indicate compression. Figure 33 displays the peak values of each gauge and how these values changed during trafficking.
