Performance of Geogrid-Stabilized Flexible Pavements

Gregory J. Norwood and Jeb S. Tingle

July 2014

Final report

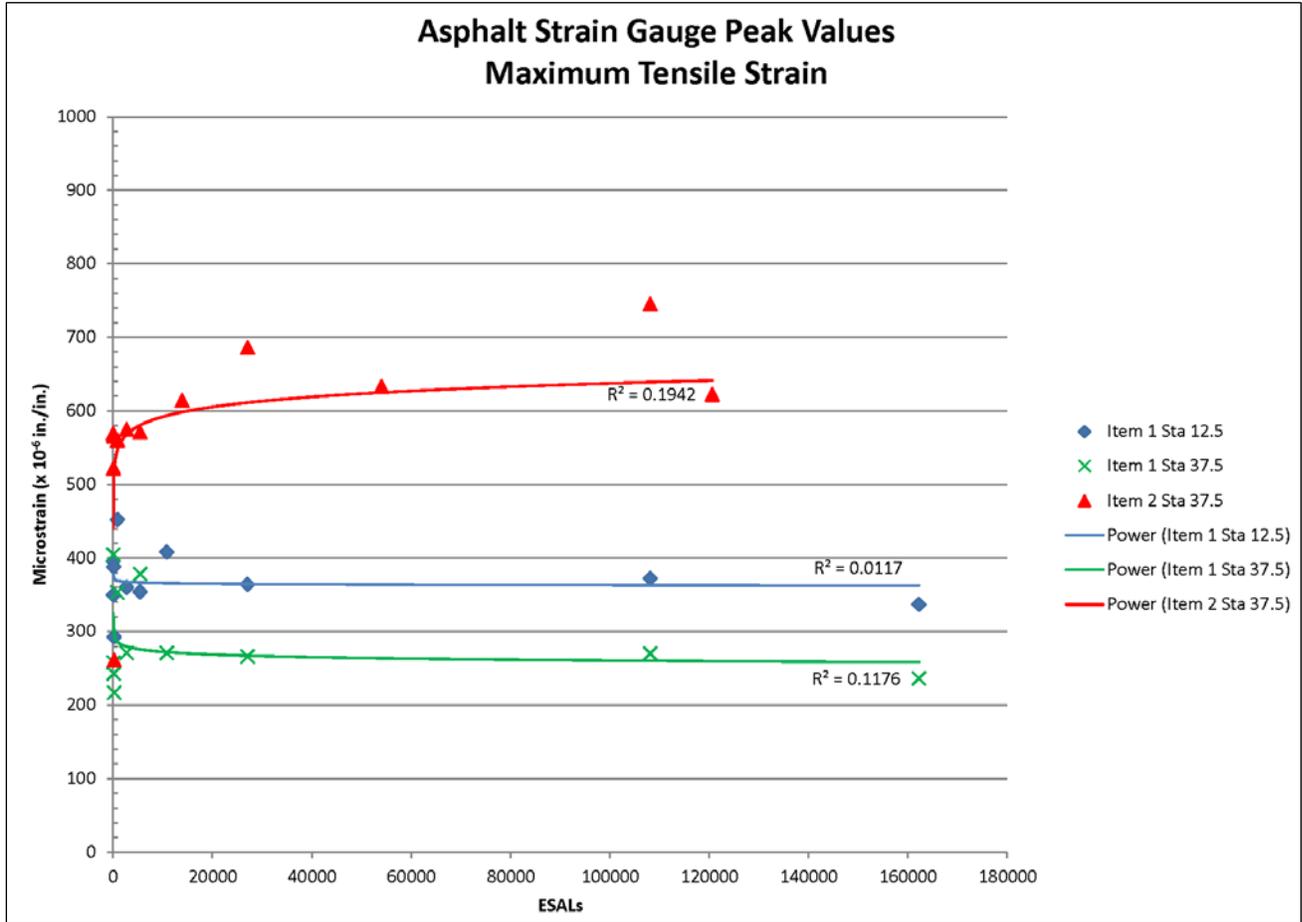
Figure 35. ASG peak tensile strain value changes during trafficking.

As displayed in Figure 35, the strain at the bottom of the asphalt layer increased immediately after the environmental chamber malfunction. The peak strain readings for Item 2 increased 12% from 614 microstrain before the event to 686 microstrain after the event. For comparative purposes, the change in max tensile strain for Item 1 for the same traffic interval was essentially zero with an actual -1.8% decrease. These readings further rein-

force the conclusion that the rutting in Item 2 was due to the elevated temperatures experienced during the equipment malfunction.

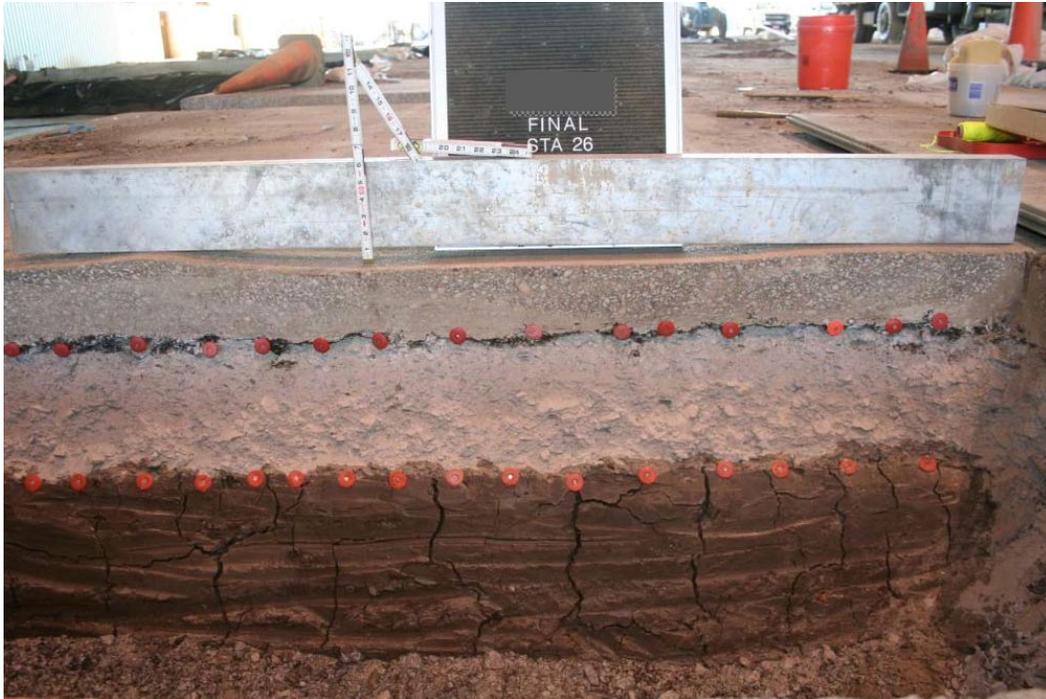
Figure 36. Item 1 excavated trench.

Upon conclusion of traffic testing, each lane was trenched in two locations to further investigate the method of pavement failure. Trench locations were based on location of maximum and minimum rutting in each lane. Each trench was approximately 3 ft in width and started with excavation of the HMA surface. Measurements of layer thickness were recorded at each location. Additionally, in-field CBR tests, nuclear density measurements, and moisture contents were conducted on each layer within the wheel path and outside the wheel path. Results from the tests are displayed in Table 8. The post-test densities for the CH subgrade material show minor changes of -0.3 and 0.8 pcf for Items 1 and 2, respectively.

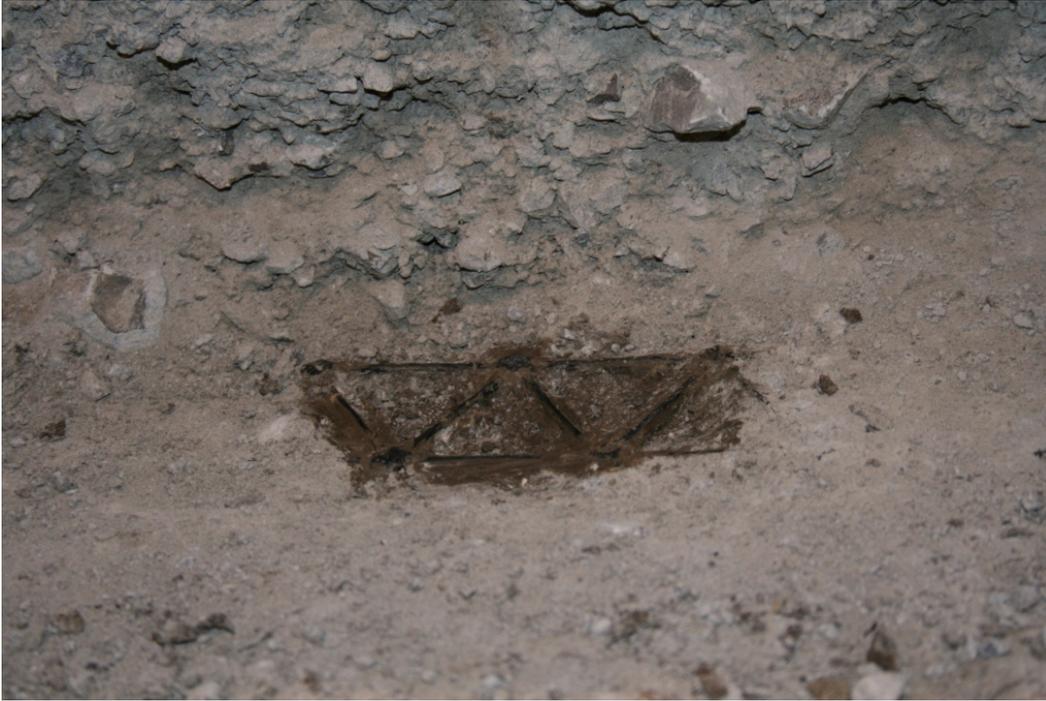
Figure 38. Excavated geogrid in Item 2.

during the temperature spike from the environmental chamber failure. Figure 38 shows the geogrid upon excavation of the overlying base-course material in Item 2. From Figure 38, the indentions in the subgrade are indicative of good aggregate strike-through and therefore good aggregate interlock with the geogrid.

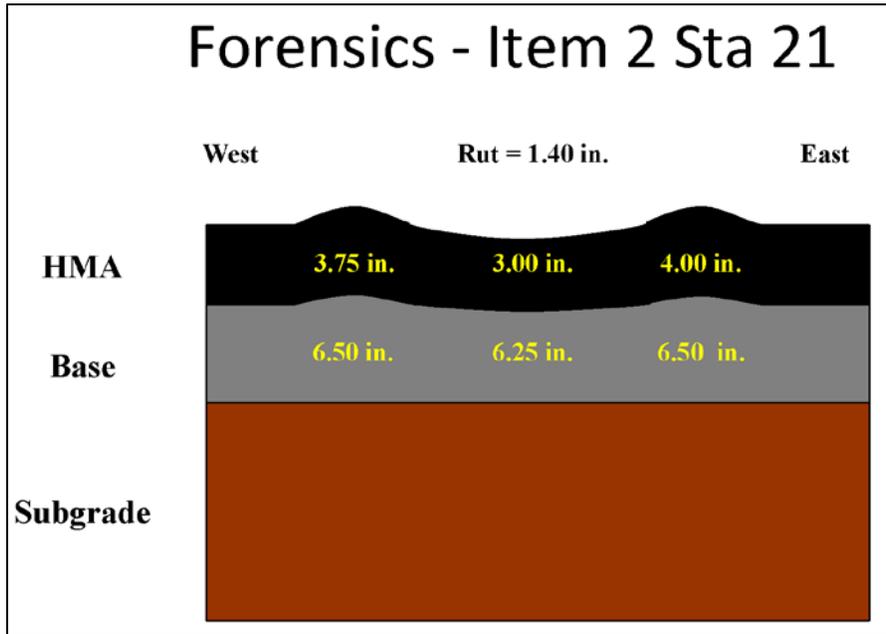
Figure 40. Item 2 post-traffic layer thicknesses.

Due to the disturbance of the base course when removing the HMA layer, CBR tests were not conducted on the top layer of the base course. The granular material was loose from the excavation, and results from any attempted CBR tests would have been unreliable. Care was taken when excavating the base course to avoid damage to the geogrid before inspection. Inspection of the trenches in Items 1 and 2 confirmed there was no failure in the subgrade for either Item. Figures 36 and 39 show the excavated trenches of both test items at the completion of post-traffic testing. Figures 37 and 40 are graphical depictions of the individual layer thicknesses post excavation. From Figures 36 and 39 it can be seen there was no damage to the subgrade layer in Item 1 and Item 2. Visual observation indicates failure occurred mostly in the HMA of Item 2. The damage in the base-course layer of Item 2 is more than likely a result of the reduced thickness in the HMA layer caused by shear flow of the asphalt
