NCAT Pavment Test Track

Opelika, Alabama

APPLICATION: Asphalt pavement reinforcement for National Center for Asphalt Technology (NCAT) test track.

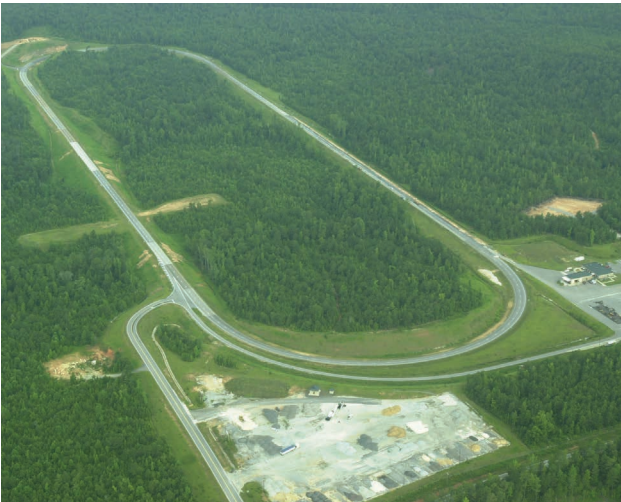
The GlasGrid Pavement Reinforcement System was installed at the National Center for Asphalt Technology (NCAT) pavement test track in Opelika, AL.

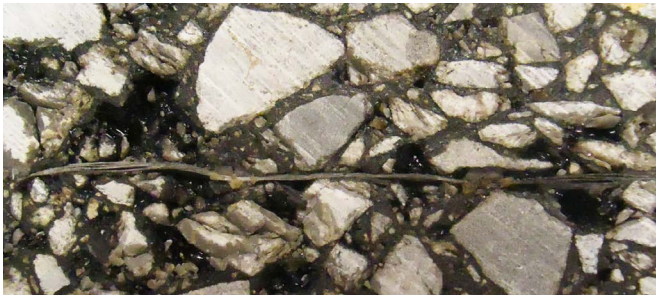
Core sample showing GlasGrid 8501 bonded to the sandwiching layers of SMA mix.

A core sample removed prior to the main excavation revealed that the GlasGrid was still intact and bonded to the sandwiching layers of the SMA mix (see photo next page). Buzz Powell, Test Track Manager of the NCAT organization, noted “GlasGrid did not create any problems during the installation of the product.”

The GlasGrid installation was examined once again. Due to the high quality of the SMA mix sandwiching the GlasGrid product, there was no significant difference in performance found between the first 100 ft (the control section) and the last 100 ft (the GlasGrid System treated section). However, longitudinal cracking was found in the control section along the centerline joint and between the inside and outside lanes while no longitudinal cracking was observed in the GlasGrid treated section. A slab was cut from the pavement section and revealed that the GlasGrid product was intact and still bonded to the SMA sandwiching layers after 5-1/2 years and 20 million additional ESALs since the first pavement excavation.

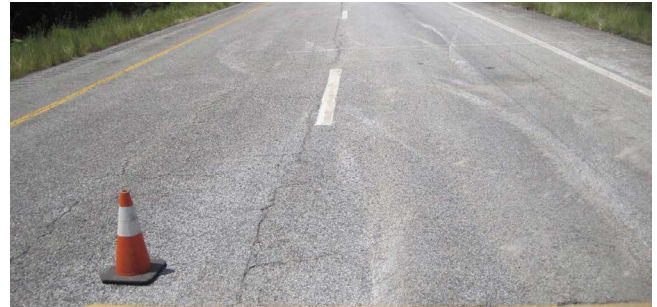
During the 2018 site visit, additional cracking was observed in the unreinforced section.

2018 SITE FOLLOW-UP The NCAT site was visited once again in 2018 after 60 million ESALs of loading. Observations revealed that the unreinforced section had more cracking present in addition to the joint cracking first observed in 2006. Also, there was now random cracking within the lane area as well as additional cracking extending from the centerline cracking. As for the GlasGrid reinforced section, cracking was now appearing, however, it is limited to only the 18 year old construction joint.

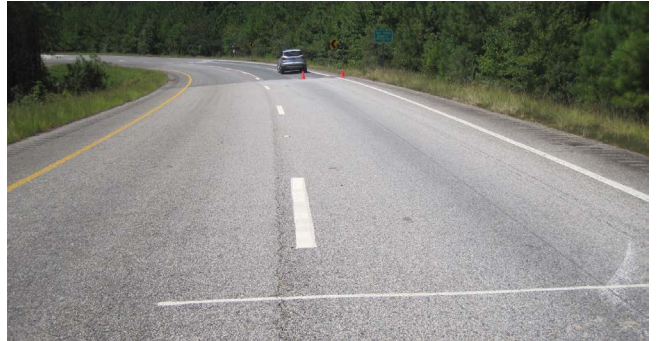
The GlasGrid reinforced section was also evaluated in 2018. After 60 million ESALs, cracking was starting to appear but limited to the 18 yr. old construction joint.
