PRELIMINARY RESULTS:

APLT In-Situ Performance Verification on Dillahunty Rd., Eddy County, NM

PROJECT NUMBER: 2015-019
LOCATION: Dillahunty Road, Eddy County, New Mexico, USA
FIELD TESTING DATE: August 27, 2015

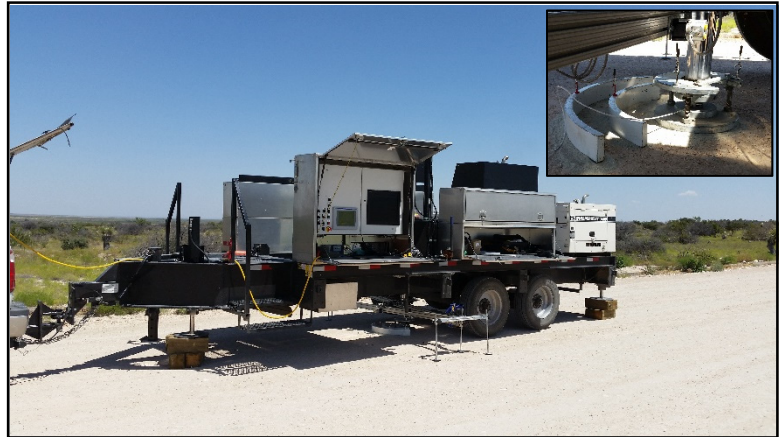
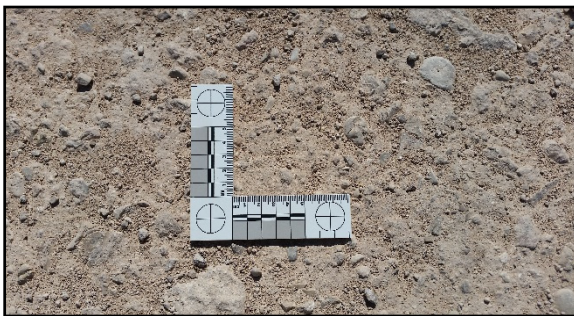
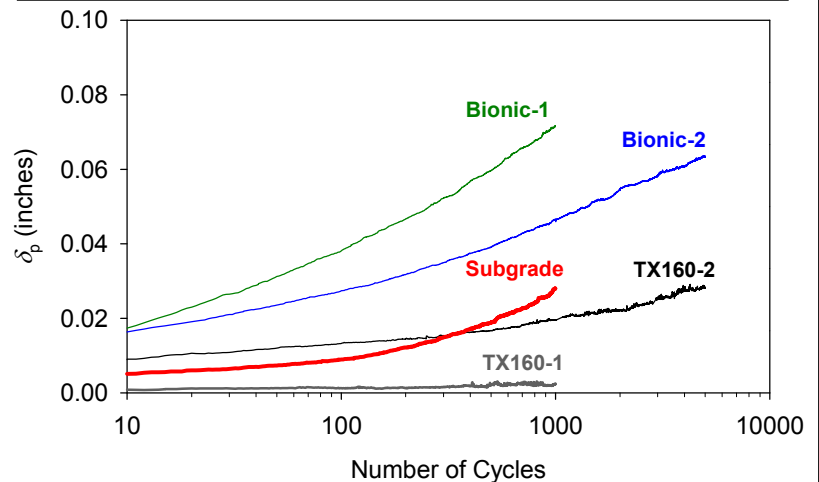
Pavement Foundation Profiles	A. 4" Bionic treated pit run rock base, 4" Class A subbase, 6+" pit run rock subbase, TX160, and subgrade B. Subgrade (desiccated, dry, and trafficked) C. 14" pit run rock subbase, TX160, and subgrade
Field Tests performed	Ingios APLT
APLT Configuration	Cyclic M_r tests at 80 psi stresses for a total of 1,000 to 5,000 loading cycles
Mechanistic Properties Evaluated	Composite M_r M_r of base M_r of subgrade Perm. def. (δ_p)

Point #	Profile	Composite* M_r , ksi	Base Layer M_r , ksi	Subgrade Layer M_r , ksi	Perm. Def.* (δ_p), in.	Comments/ Notes
Bionic-1	A	74	—†	—†	0.0718	1,000 cycles @ 80 psi
Bionic-2	A	74	—†	—†	0.0633	5,000 cycles @ 80 psi
Subgrade	B	NA	NA	499	0.0280	1,000 cycles @ 80 psi
TX160-1	C	156	—†	—†	0.0025	1,000 cycles @ 80 psi
TX160-2	C	105	—†	—†	0.0283	5,000 cycles @ 80 psi
