# Pavement Performance Evaluation of Geogrid Stabilized Roadways

Conference Paper · October 2020

Prajwol Tamrakar, Mark H. Wayne and Mariana Stafford, Tensar International Corporation, 2500 Northwinds Pkwy, Suite 500, Alpharetta, GA 30009, USA

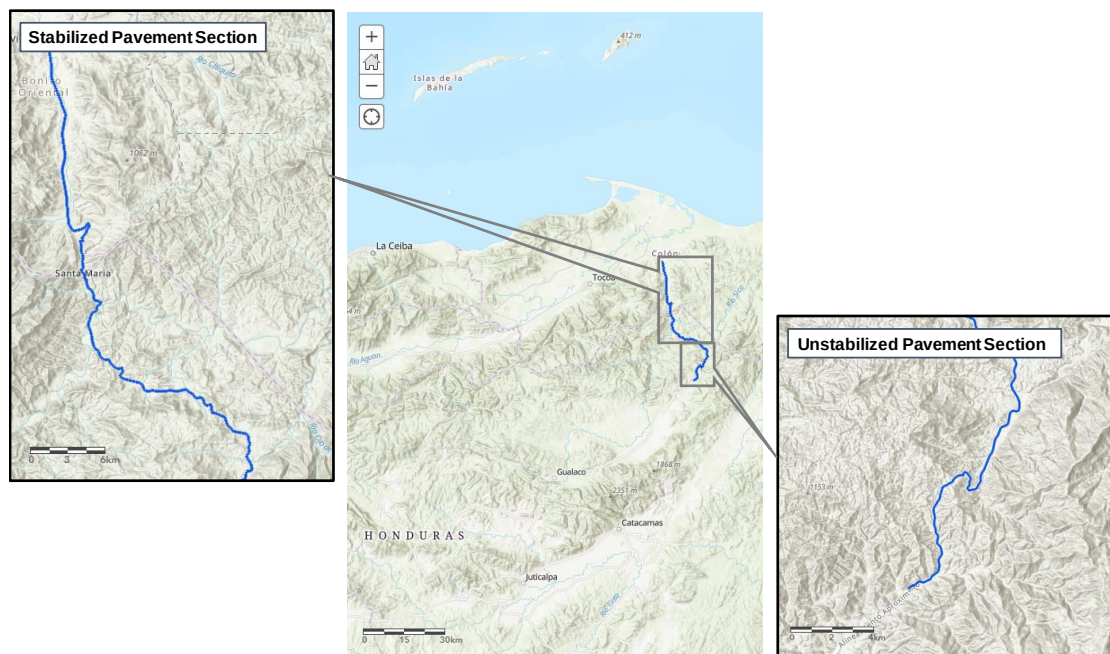
Figure 1. Project Location

Figure 1 shows the project location including geogrid stabilized and unstabilized pavement sections. The total lengths of geogrid stabilized and unstabilized pavements are 46 km and 18 km, respectively. The pavement sections were constructed in 2016. The pavement was heavily trafficked since its construction. The annual average daily traffic (AADT) is about 1010, but expected to double by 2035. The majority of the vehicles travelling through this corridor is a T3-S2 type of truck.

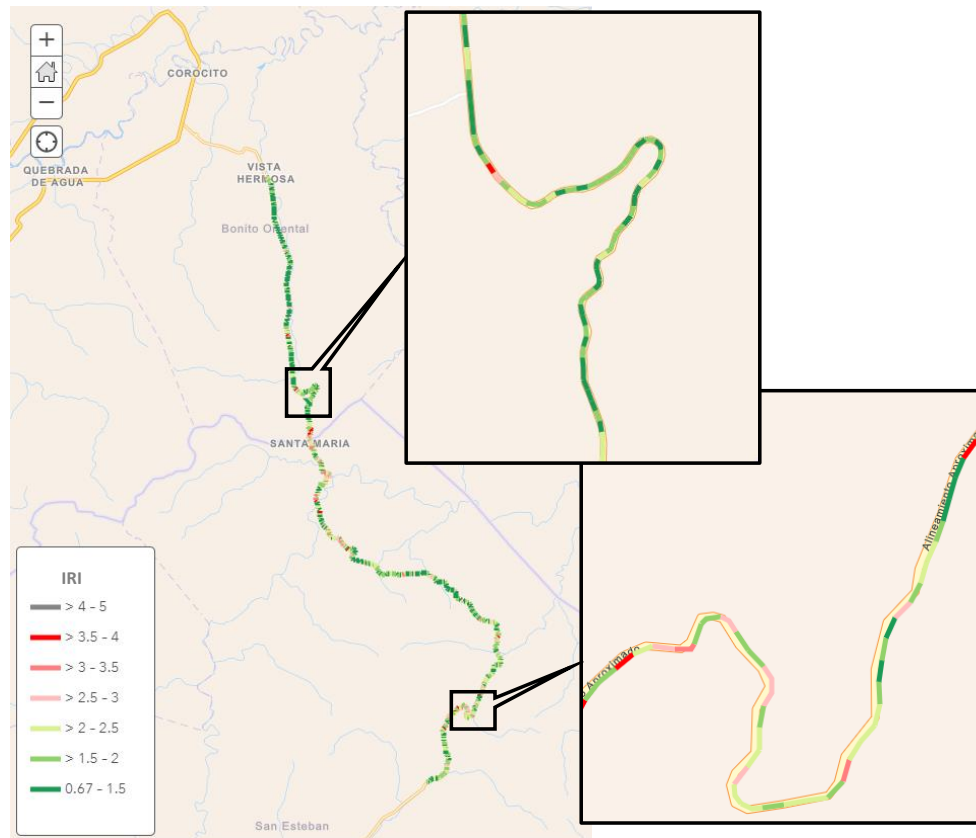
Figure 2. IRI Map

Figure 2 shows variation in the measured IRI for the entire project site through the color-coded map. The legend in the figure represents the IRI ranges. For each pavement section, the presented IRI value is an average of the north- and south-bound lanes. Using the map portal, the distribution of pavement IRI for every 100 m interval can be observed. Such a map can be beneficial for identifying locations of highly roughened pavement sections which could indicate the presence of pavement distresses.

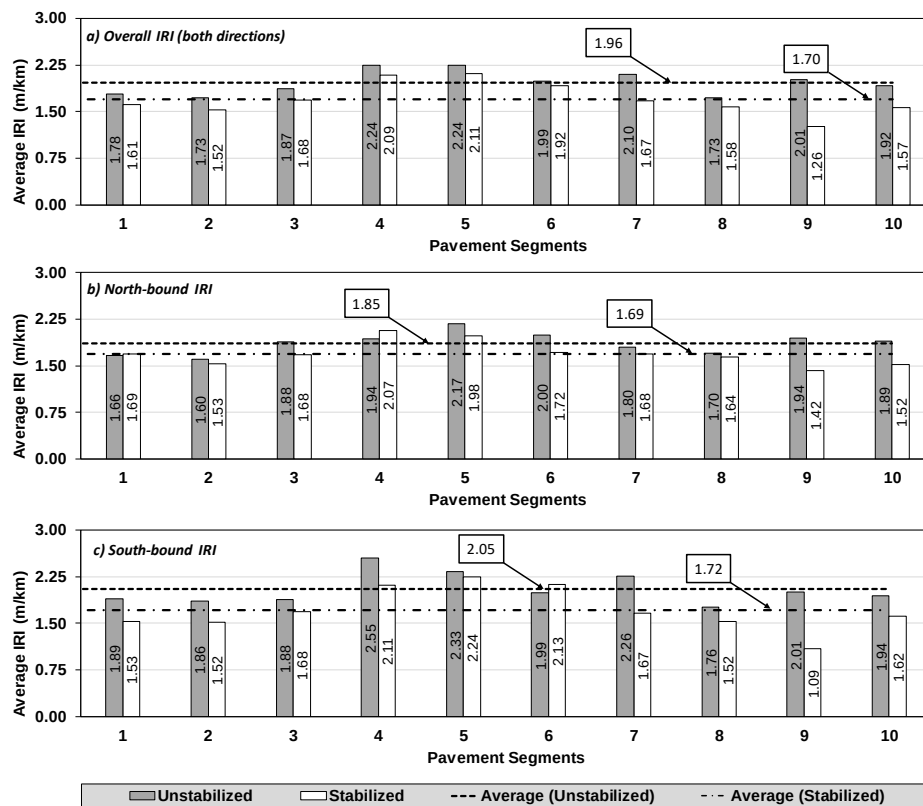
Figure 3. Measured IRI of Pavement Sections

In order to present measured IRI for different pavement sections, the total pavement section is divided into 10 pavement segments (see Figure 3). Each pavement segment represents 10% of the total pavement length. For example, segment 1 for stabilized pavement represents the first 4.6 km length of the pavement. On the other hand, segment 1 for unstabilized pavement represents the first 1.8 km length of the pavement. Segment 1 and segment 10 represent the southernmost and northernmost segments. As seen from Figure 3a, the overall IRI for geogrid stabilized pavement is less than that for the unstabilized pavement. The average IRIs for geogrid stabilized and unstabilized pavement were 1.70 m/km and 1.96 m/km, respectively. In other words, the IRI of geogrid stabilized pavement was 14% less than that of unstabilized pavement.

Figure 3 also provides pavement IRI for the north- and south-bound lanes (see Figure 3b and Figure 3c). The average IRIs of the north-bound lane for geogrid stabilized and unstabilized pavements were 1.69 m/km and 1.85 m/km, respectively. Similarly, the IRIs of the south-bound lane for geogrid stabilized and unstabilized pavement were 1.72 m/km and 2.05 m/km, respectively. The geogrid stabilized pavement IRI for both directions were similar whereas the unstabilized pavement IRI for the south-bound lane was slightly higher than the north-bound lane. This fact indicates that the geogrid

stabilized pavement has a uniform distribution of pavement roughness in both north- and south-bound pavements. On the contrary, the unstabilized pavement had a non-uniform distribution of pavement roughness. The basic statistics of measured IRIs for geogrid stabilized and unstabilized pavements are reported in Table 3.
