US-20; Sheep Falls Road to Pine Haven Drive

Fremont County, ID

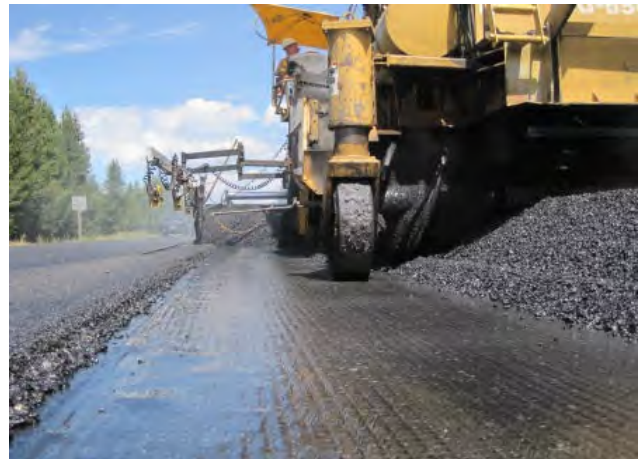
A Glasgrid 8511TF reinforced overlay was utilized to improve the long term performance of the overlay and slow down reflective cracking.

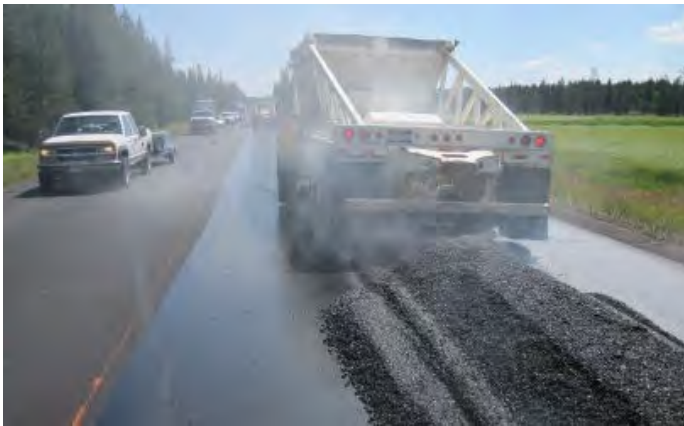
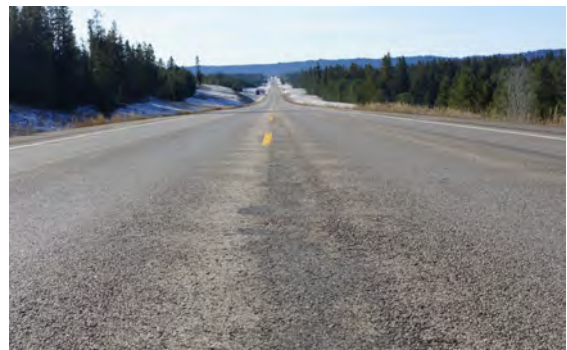
Seven Year Follow-up:

After 7 years of traffic and severe temperature fluctuations, ranging from lows around -40 degrees F to highs around 90 degrees F in the Summer, this section of US-20 is performing well as shown in the photo below.
